Otis Tufton Mason House:

Otis Tufton Mason House: Context and Assessment

Fairfax County, Virginia

April 25, 2014 • Draft Report
New South Associates Technical Report 2378

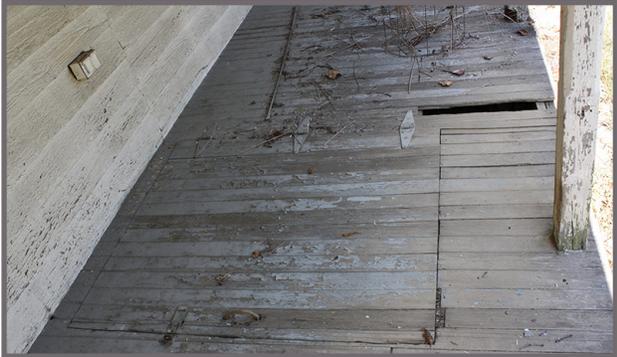
<p>Missing Floorboards and Chipping Paint</p>
PORCH	<p>Boards are missing or shifting in some places.</p>

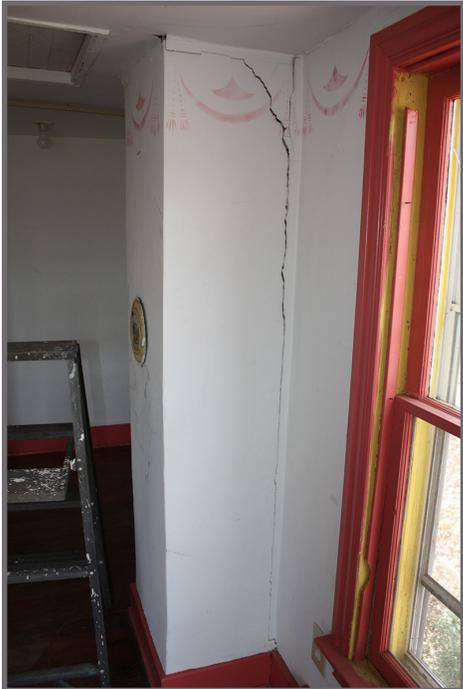
<p data-bbox="240 1808 415 1835">Damaged Drywall</p>	<p data-bbox="756 953 1357 1022">The large room drywall includes both patched and unpatched holes.</p>

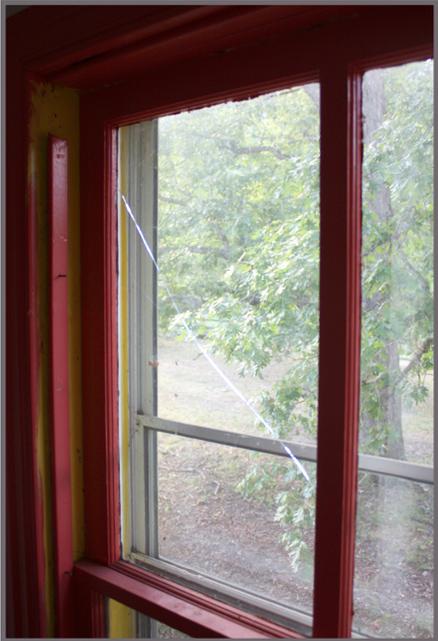
<p>Broken Pane</p>	<p>Though covered by a storm window, the lower sash of the northeast window of the larger room is missing. A matching vertical two-light sash is currently housed in the cellar.</p>

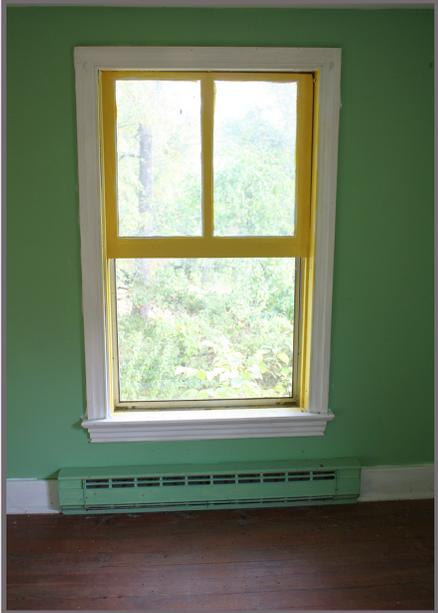
<p>Damaged Wood Strips</p>
<p>The windowsill on the southeast wall of the larger room is currently detached.</p>
