US ROUTE 1 IMPROVEMENTS

POHICK CHURCH PRE-CONSTRUCTION SURVEY AND VIBRATION MONITORING PLAN

QEA PROJECT NO. 31304000

16 July 2014

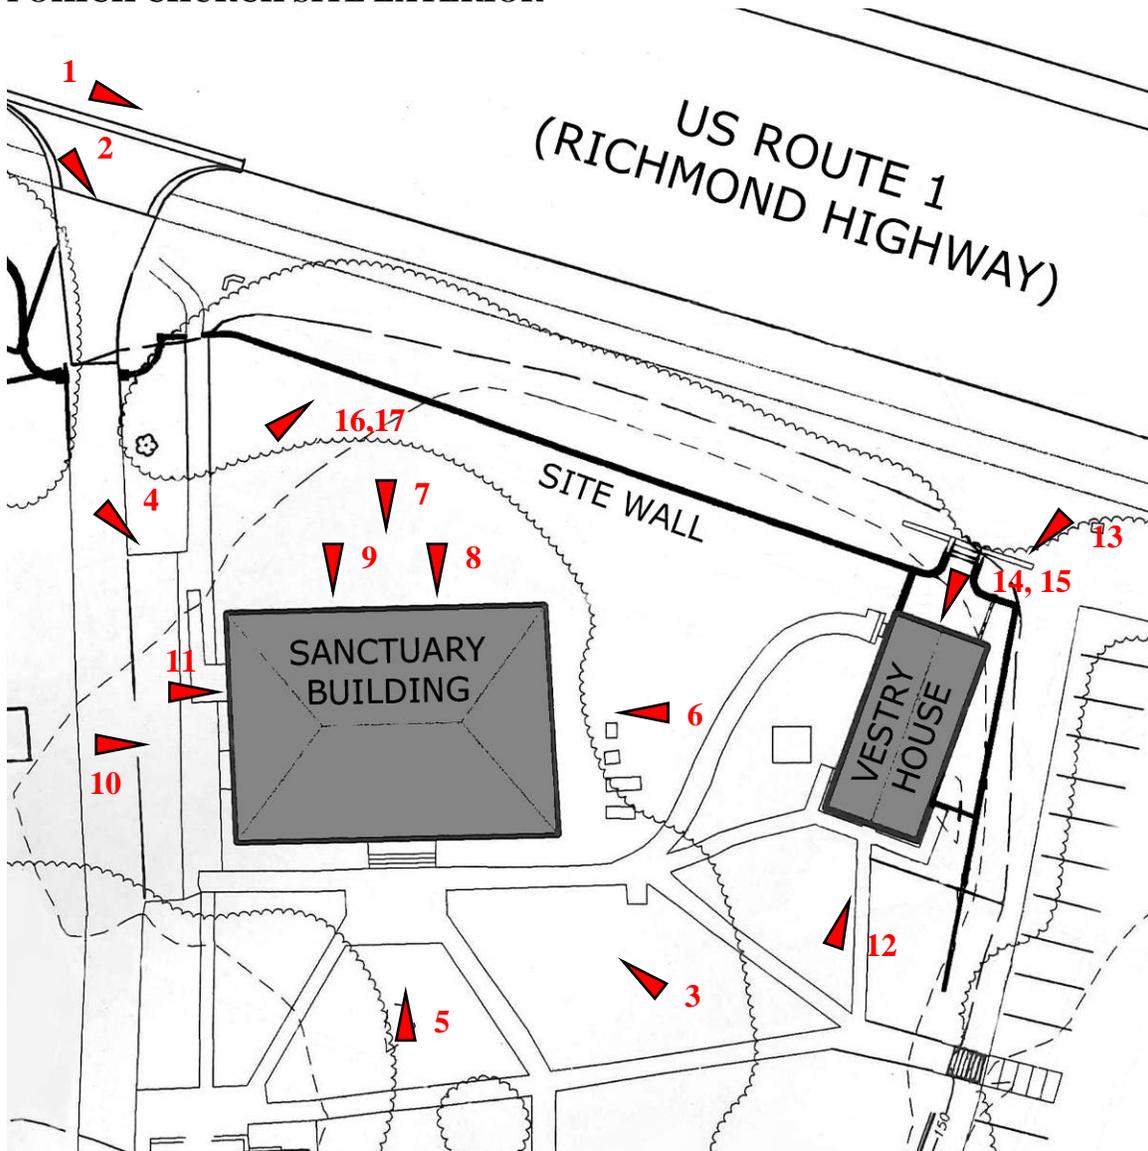
Site Plan Detail

Used on following pages to indicate approximate location of crack monitors referenced in report.

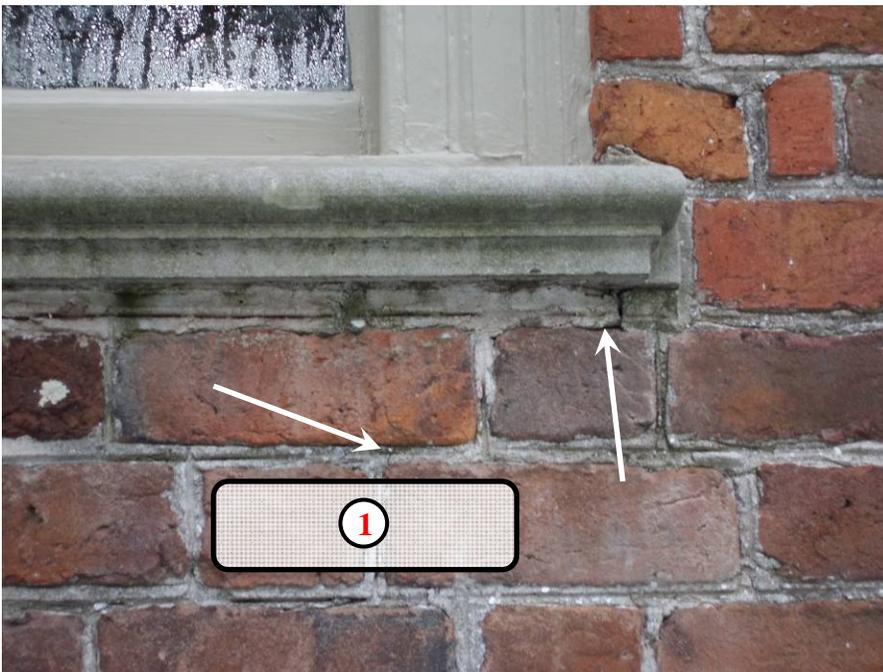
Image 8: Detail at north façade of sanctuary building

Arrows indicate existing crack under window. Approximate location of proposed crack monitor is indicated.

Robert Silman Associates recommends providing crack monitors on existing cracks on the sanctuary building, Vestry House, and site wall. On the sanctuary building, two crack monitors should be placed on existing cracks under first floor windows on the north side exterior of the building. On the Vestry House, one monitor should be placed on an existing crack over the north door. On the site wall, one crack monitor should be placed on an existing crack on the south of face wall, roughly north of the sanctuary building.

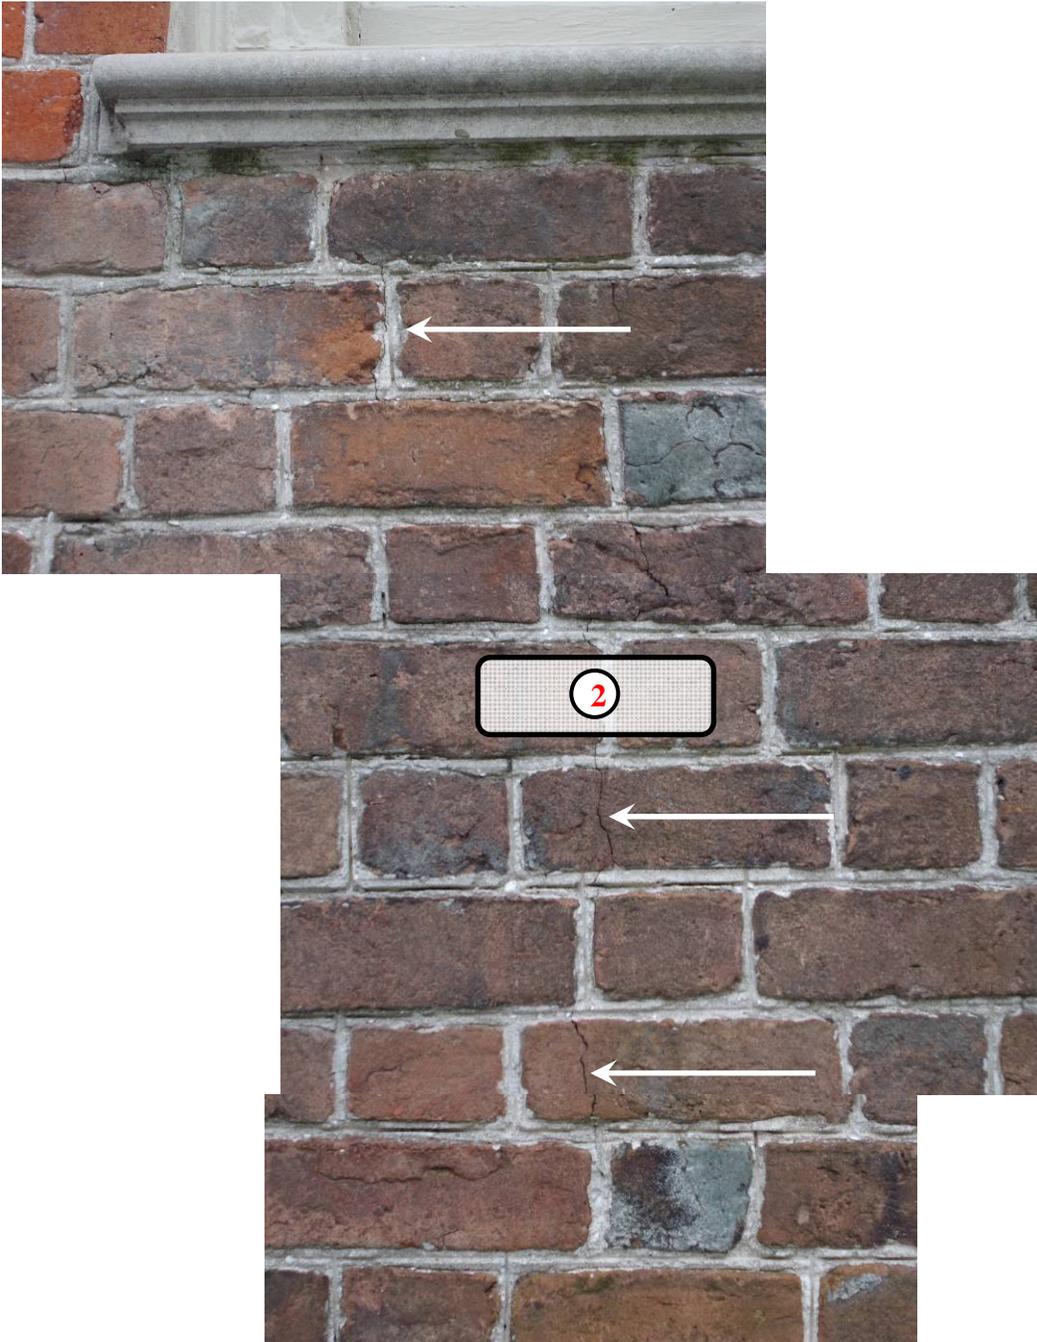
Image 9: Detail at north façade of sanctuary building
Arrows indicate existing crack under window. Approximate location of proposed crack monitor is indicated.

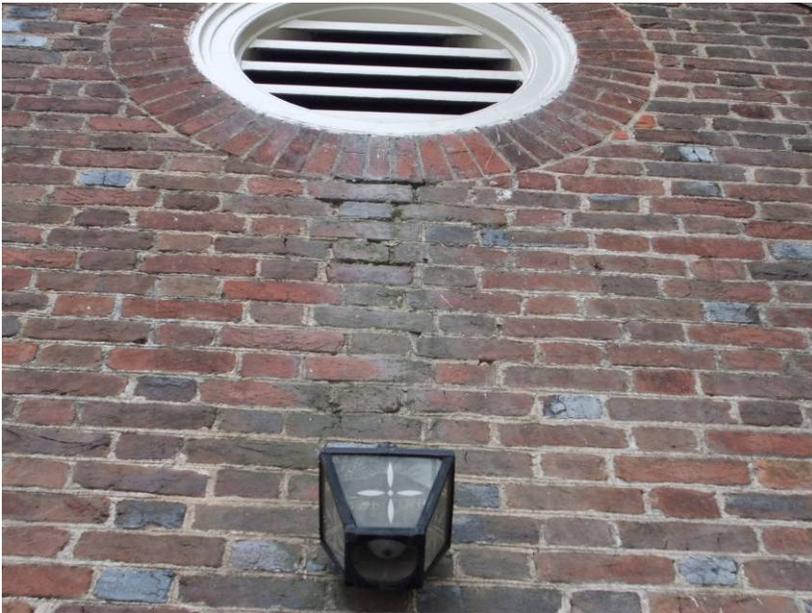
Image 14: Vestry House, north elevation detail
Note existing crack below round vent.

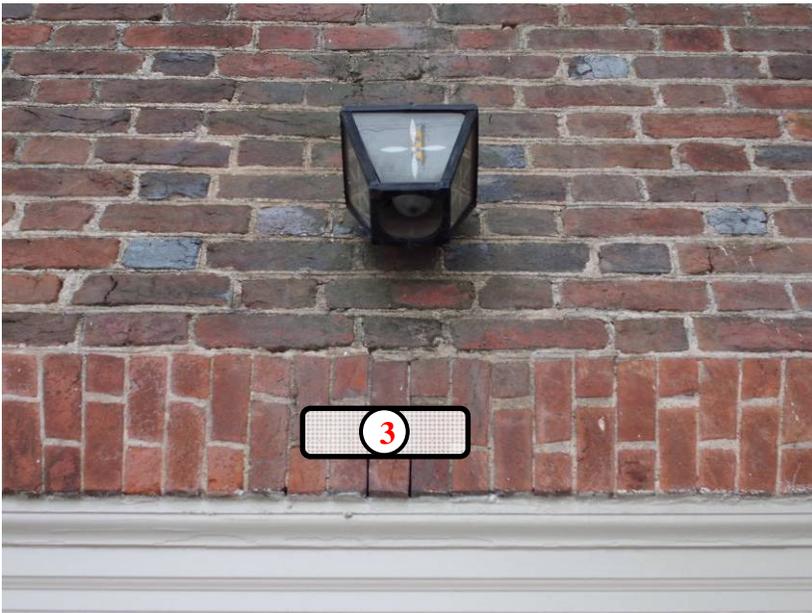
Image 15: Vestry House, north elevation detail
Approximate location of proposed crack monitor is indicated.

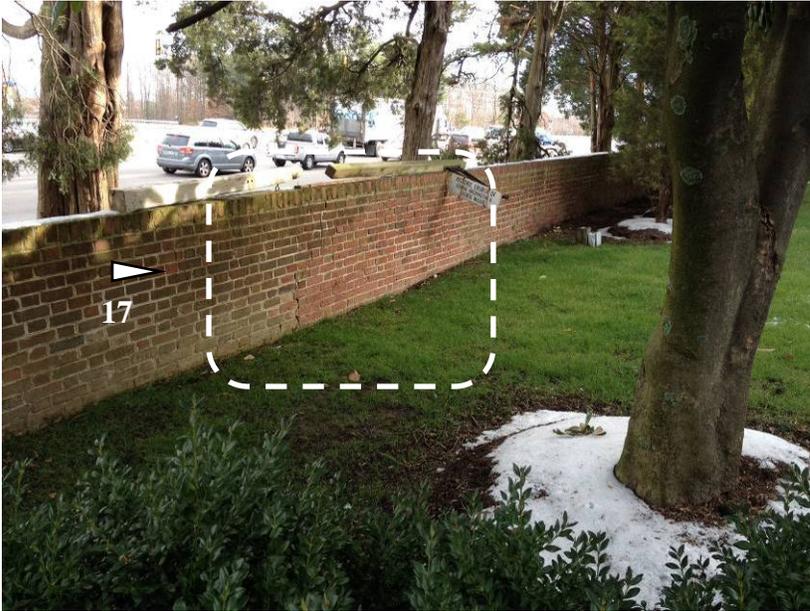
Image 16: Site wall

South face of wall. Route 1 is visible in the background. Refer to following image for detail of area indicated by dashed outline.

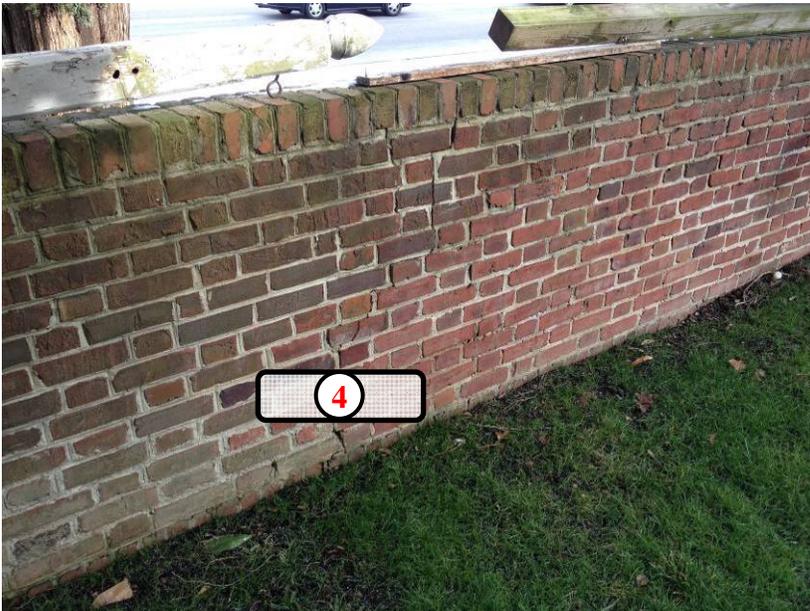
Image 17: Site wall

Approximate location of proposed crack monitor is indicated.

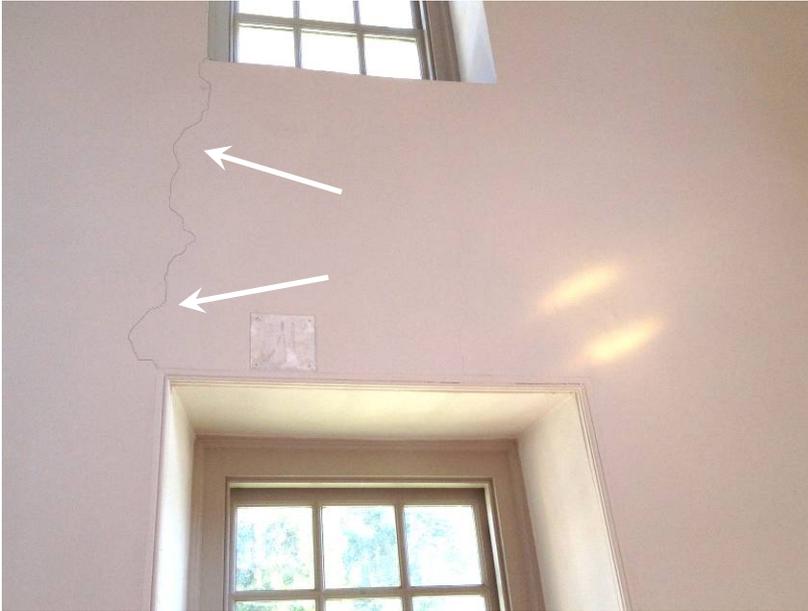
Image 22: Interior detail, north wall, east side

Note existing crack between windows, indicated by arrows. Crack has been digitally emphasized in image. Refer to Survey Video for actual conditions.

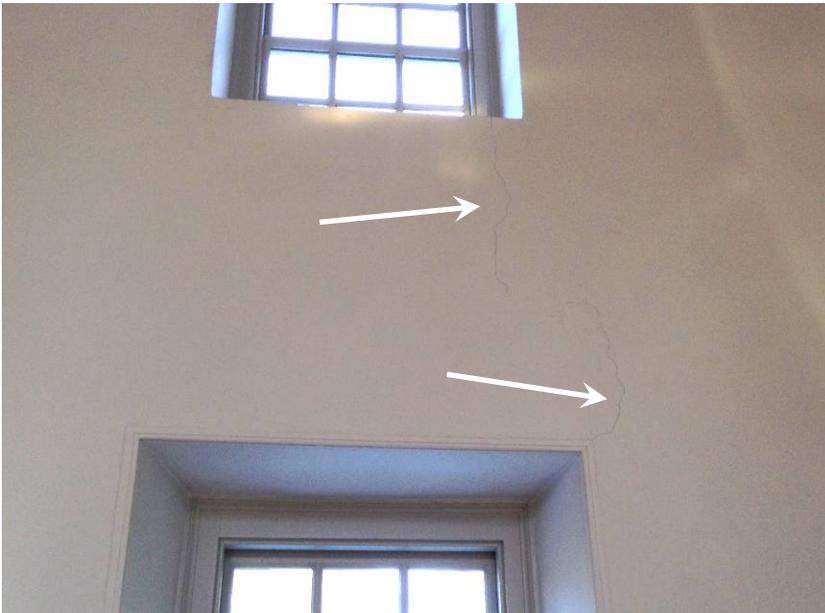
Image 23: Interior detail, north wall, east side

Note existing crack between windows, indicated by arrows. Crack has been digitally emphasized in image. Refer to Survey Video for actual conditions.

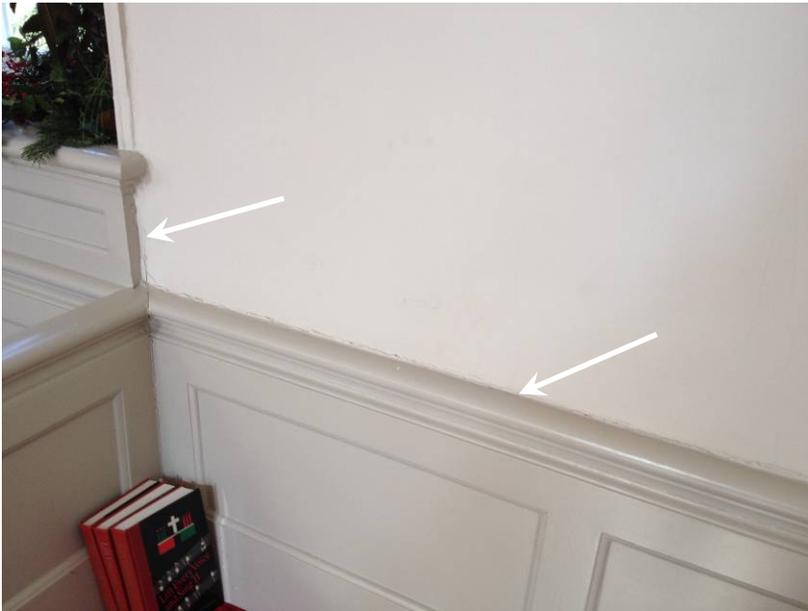
Image 24: Interior detail, north wall, east side
Note cracking in plaster at joint with wood wainscot, indicated by arrows.

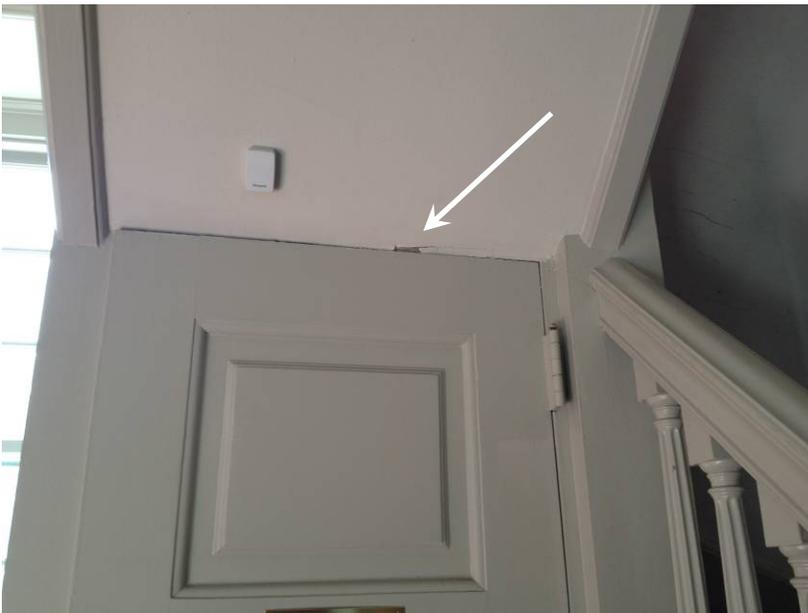
Image 25: Interior detail, under balcony
Note existing damage to plaster above door, indicated by arrow.
