VERIFICATION OF GROUTING Using 3D Seismic Tomography

Publication No. FHWA-CFL/TD-11-007

September 2011

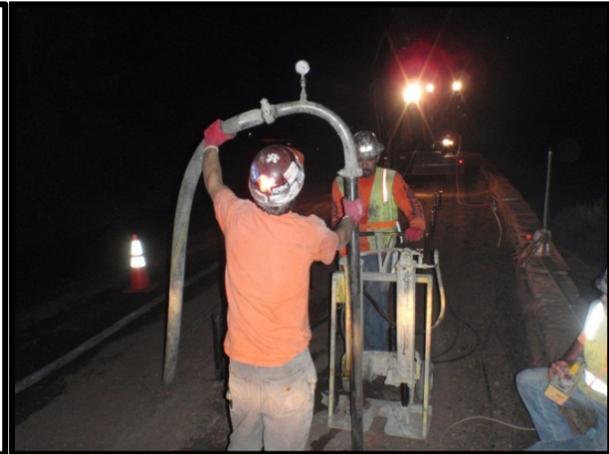
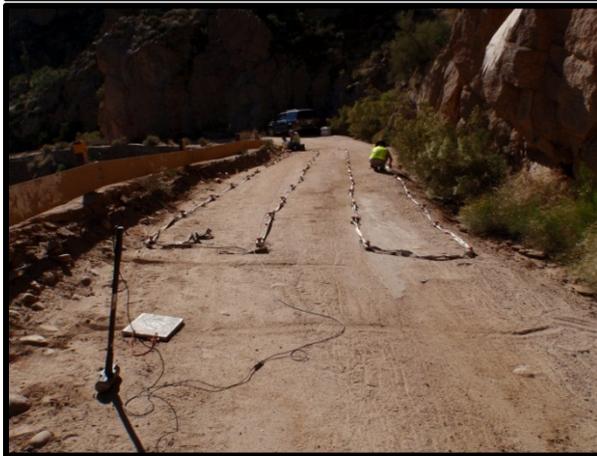
Cover Photos, clockwise from top left: Pre-grouting seismic tomography, compaction grouting at Zion National Park site, post-grouting seismic tomography, and seismic data collection at Apache Trail site.

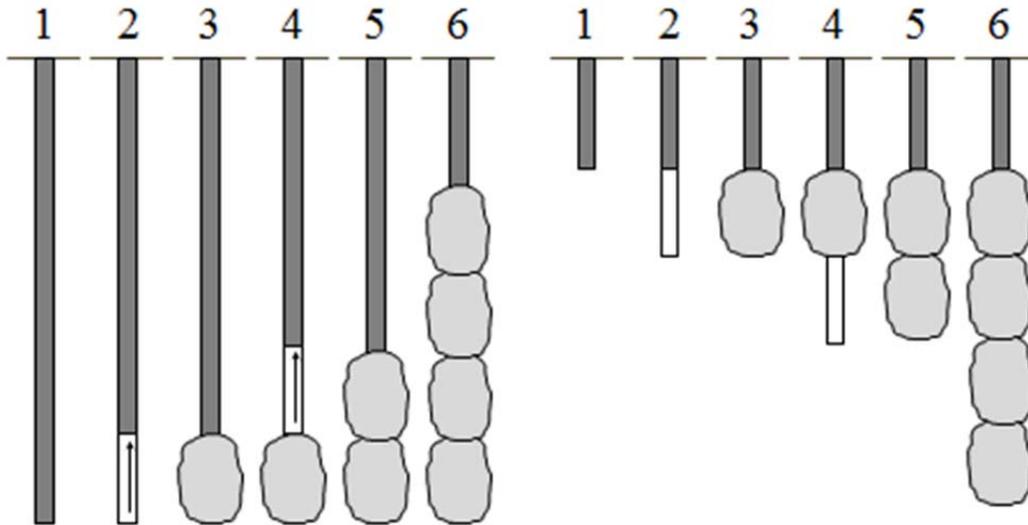
Figure 2.1. Schematic. (a) Bottom-up, and (b) top-down compaction grouting (after ASCE, 2010)

the casing is advanced to the full depth of the zone to be treated, with grouting proceeding upward in stages as the casing is removed, usually until insufficient confinement is obtained. For situations where greater improvement is required at shallow depths (1-3 m), or where surface heave must be carefully controlled, the top-down method can be used. The additional time and costs involved in the top-down method, as each stage must be re-drilled to advance the casing to the next stage, are offset by the grouting verification provided by drilling as well as the increased confinement at the surface. A combination of the two methods can also be used, with the first stage being injected at the most shallow depth, and the remaining stages advancing upward from the deepest depth as in the bottom-up method.

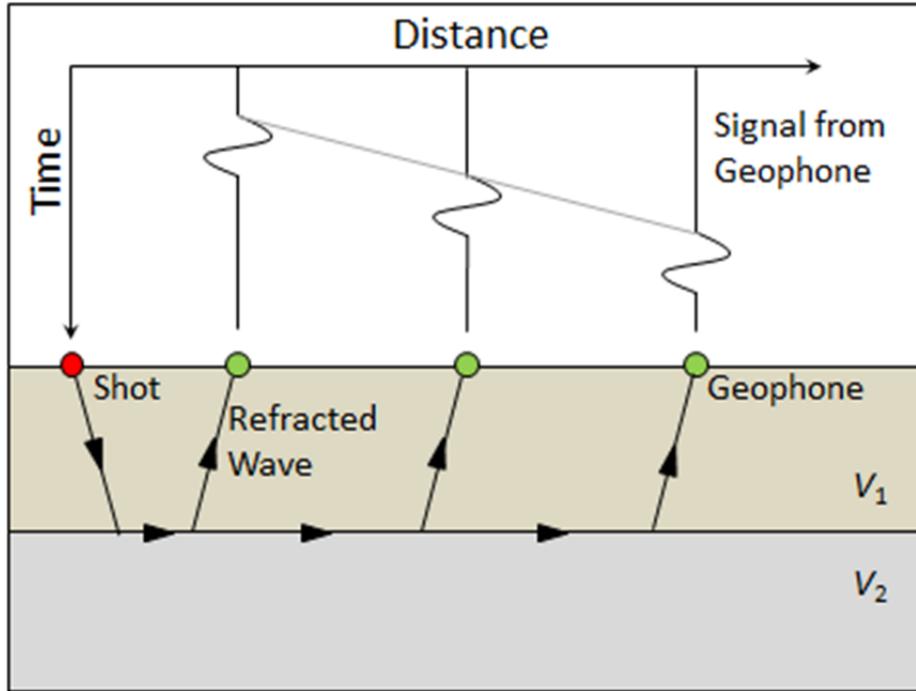
Figure 3.2. Schematic. Simplified seismic refraction process showing reflected waves and arrivals as recorded by geophones.

where α_1 and α_2 are the angles made with the normal to the boundary by the incident and refracted rays, and v_1 and v_2 are the seismic velocities of the incident and refracted rays, respectively. This relationship forms the basis for traditional 2D seismic refraction interpretation, which can be extended to multiple layers of increasing velocity with depth. Figure 3.2 provides a simple illustration of the principles fundamental to 2D seismic refraction procedures, where an incident wave is recorded at different times by geophones arranged in a straight line radiating outward from the source location. Figure 3.3 shows a typical distribution of arrival times for surface, body, and air waves within a travel-time plot recorded by 2D geophones during a seismic refraction survey.

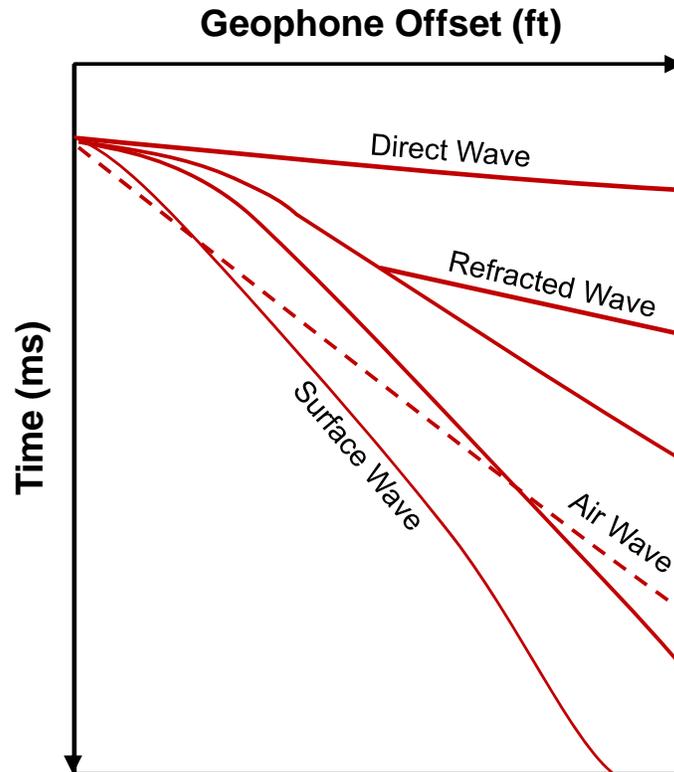
Figure 3.3. Graph. A comprehensive interpretation of body-, air-, and surface-wave events on seismic travel-time plots (after Park et al. 2001).

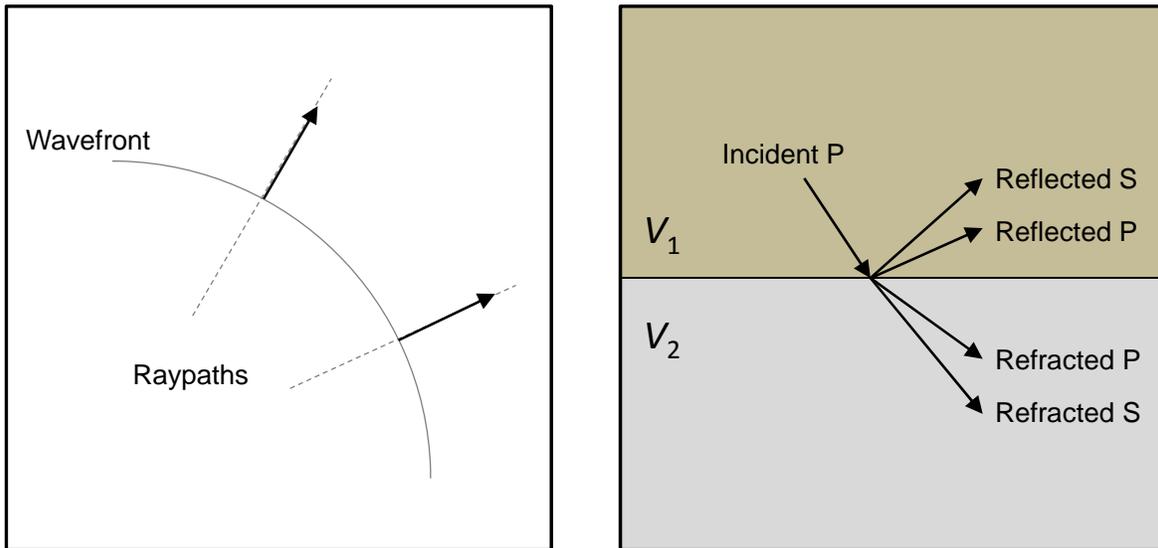
Figure 3.4. Schematic. (L) Illustration of raypaths normal to the surface of a propagating wavefront and (R) reflected and refracted waves resulting from an incident p-wave.

Sirles et al. (2006) defined a ray as “a region in the model that has the highest contribution to the first arrival time, and typically descends from the source at the ground surface to higher velocity layers before ascending to the surface receiver(s).” This definition relates to the predecessor to the software used for tomography generation as part of this study, GSR3D. A complete review of seismic wave propagation and ray theory has been provided by Červený (2001).

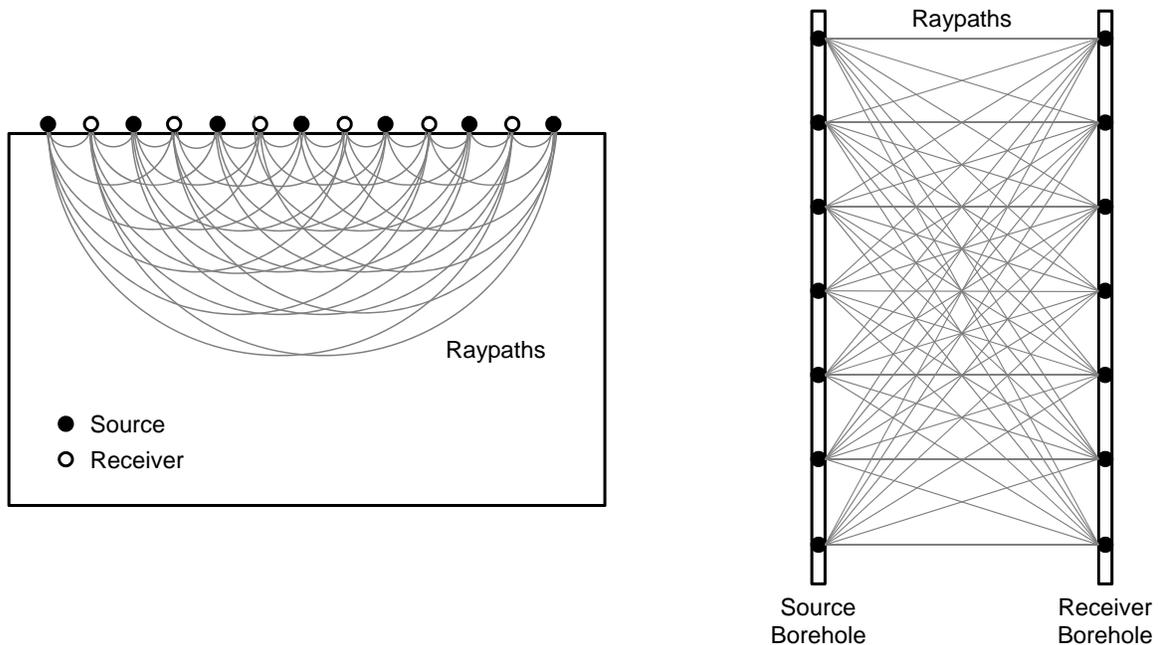
Figure 3.5. Schematic. Source and receiver locations along with raypath coverage for typical (L) surface seismic and (R) subsurface seismic surveys.

Another method which can be used to obtain 3D seismic tomography involves the use of subsurface source and receivers located in boreholes, also referred to as down-hole or cross-hole methods. This technique has been successfully used to investigate an active sinkhole causing property damage in a residential neighborhood (FHWA CFLHD 2003), detect abandoned coal mines beneath a retaining wall, and verify the effectiveness of jet-grouting beneath a bridge pier foundation (Hanson et al. 2000). Figure 3.5 illustrates typical source and receiver layouts between both surface and subsurface methods, which would allow for 2D tomography generation. The linear raypaths shown for the subsurface arrangement would only be accurate for a constant-velocity model where no refraction would occur. Additional geophone lines or boreholes would allow for 3D tomography to be created. Cross-hole sonic logging (CSL), which is a non-destructive evaluation method used to evaluate the integrity of drilled shaft foundations, can also be used to develop 3D seismic tomography. Haramy (2006) also showed that 3D CSL methods could be used to successfully determine seismic velocity differences before and after grouting of drilled shafts which were found to have defects.

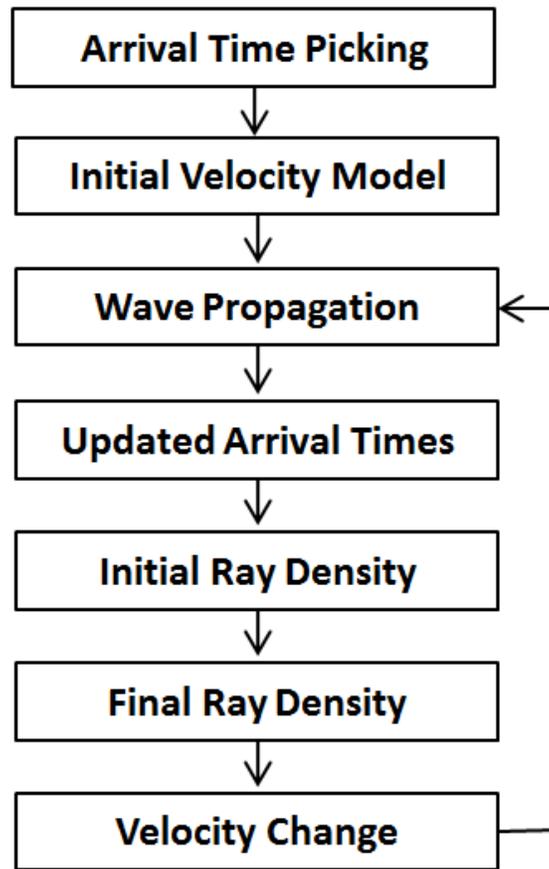
Figure 3.6. Flowchart. Simplified processing procedure utilized by GSR3D.

Boundary conditions for the tomography models generated by GSR3D cannot be specified by the user, and the results of different boundary conditions on the results were unable to be verified for this study. As waves which are propagated through the model do not have the ability to reflect along the model boundaries, there is no chance that the calculated arrival time can be influenced by these boundary reflections. The tomographic volume can therefore be considered as a region within an infinite elastic half space. Also, as the calculated seismic wave arrival times are determined from the propagation of seismic wavefronts and not their reflections, only the arrival of this wavefront will have an influence on the resulting tomography, and any other potential waves, such as shear waves that arrive at later times, are not considered.

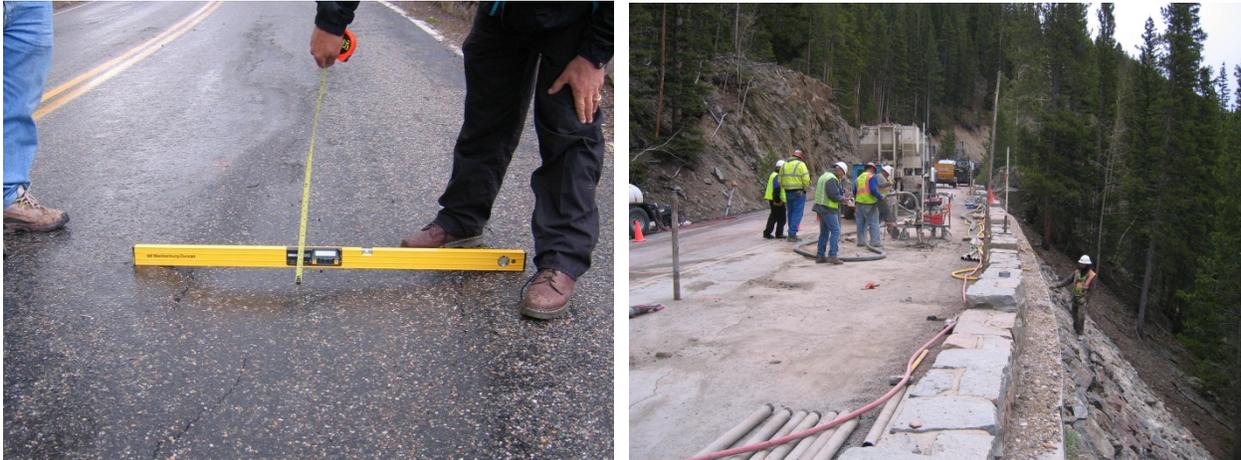
Figure 3.7. Photo. Photographs showing (L) differential settlement of roadway and (R) compaction grouting operations at Rocky Mountain N.P.

One of the first studies involving the use of 3D seismic tomography for the assessment of compaction grouting effectiveness as part of roadway stabilization projects took place during the summer of 2007. Engineers with FHWA-CFLHD were tasked with rehabilitating a failed culvert that had been causing significant roadway settlement and cracking along Trail Ridge Road in Rocky Mountain National Park. The GSR3D program was investigated to determine seismic tomography before and after ground improvement at the site. Compaction grouting was used to stabilize roadway settlement caused by piping of fines from the subgrade due to a failed culvert. Before and after grouting, seismic data was collected using a sledgehammer impact on the ground surface as the input source while the refracted waves at different distances from the source were measured using geophones. The GSR3D program was used to interpret the arrival times of different waves at the different geophones. The method proved effective in producing pre- and post-grouting volumetric velocity difference images allowing for a more thorough assessment of ground improvement at the site. Further details relating to the site, the grouting operations carried out for the roadway remediation, and the seismic tomography investigation can be found in Haramy et al. (2009).

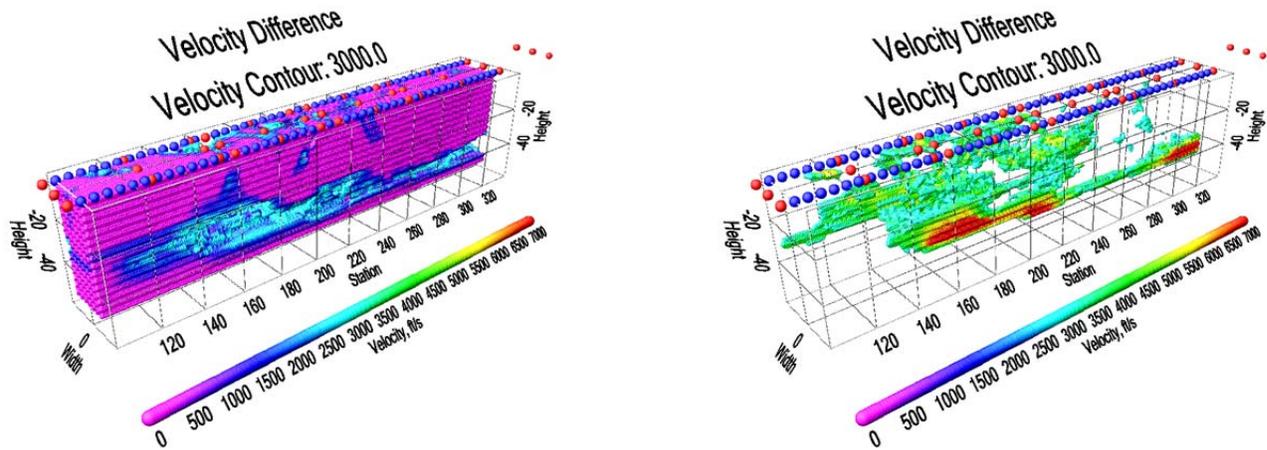
Figure 3.8. Graph. Pseudo 3D difference tomography from Rocky Mountain National Park, Colorado, compaction grouting site, showing seismic velocity differences (L) less than 3000 ft/s and (R) greater than 3000 ft/s, on a scale of 0 to 7000 ft/s.

From the results shown in Figure 3.8, the 3D difference tomography shows considerable increases in seismic velocities in the vicinity of the failed culvert. Records of the injected grout volumes, which show the highest grout injections near the midpoint of the volume, correlate well with the results of the seismic tomography. These results can be considered reasonable, as the highest degree of improvement could be expected near the midpoint of the volume where the failed culvert pipe was located, and the surrounding soils were believed to have been eroded and deteriorated. The existence of negative velocity differences in the resulting difference tomography is unknown, as the scales chosen for Figure 3.8 only displays positive velocity differences.

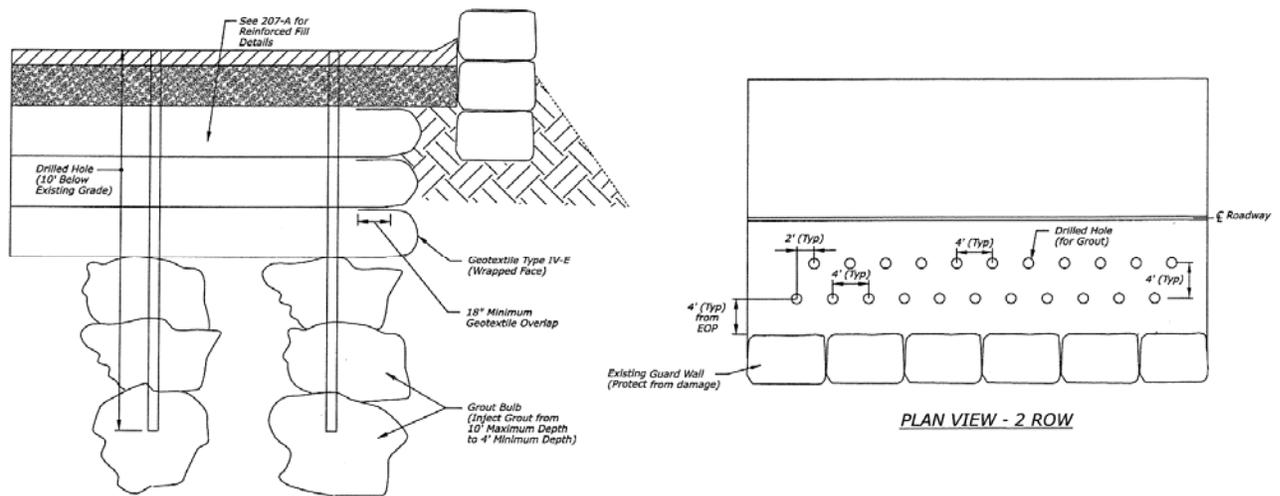
Figure 4.1. Schematic. Typical compaction grouting profile and layout at the Zion National Park.

During compaction grouting, dial gauges were used to visually monitor and record minimum and maximum injection pressures and a water manometer was used to detect ground heave. Grout takes were recorded by counting the number of strokes of the grout pump cylinder, which was calibrated to the cubic foot. Following grouting, the upper 1 m (3 ft) of the road surface was excavated to allow for replacement with reinforced compacted fill. This excavation revealed asphalt thicknesses as much as 1 m (3 ft) along the centerline and as much as 1.5 m (5 ft) or more along the shoulder. Previous boreholes showed asphalt thicknesses of only 0.13 to 0.25 m (5 to 10 inches), indicating more settlement had occurred at this location and there was a potential inversion of the subsurface density profile. Compaction grouting was performed on a staggered 1.2 m (4 ft) pattern to depths up to 3 m (10 ft). Figure 4.1 provides a typical construction detail for the compaction grouting layout, and Table 4.1 summarizes quantities.

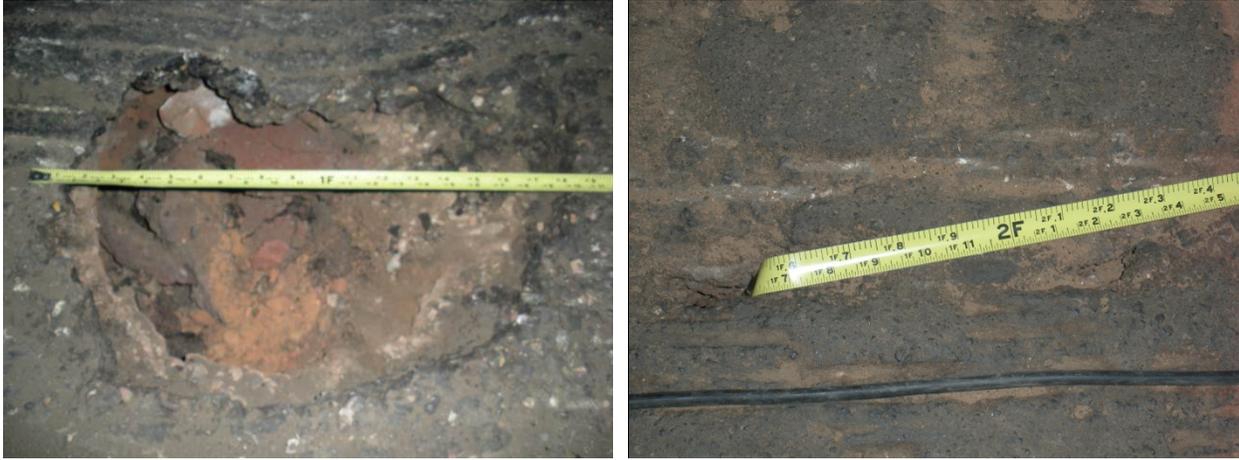
Figure 4.2. Photo. Voids beneath roadway surface daylighting at Zion National Park: (L) Large void opening resembling a pothole, more than 0.5 m (1.5 ft) in width; and (R) small hole in pavement surface observed to open to a much larger void beneath pavement.

Figure 4.2 also provides some illustration of the problems observed at the roadway surface in the vicinity of the grouting and seismic survey locations. In some areas of the roadway, large voids were present in the pavement, which, according to Park Service personnel, had to repeatedly be filled by Park maintenance staff to prevent the traveling public from exposure to an unsafe situation. In other areas, small holes were observed in the pavement ranging from approximately 2 to 5 cm in diameter, which upon closer inspection, connected to much deeper and larger voids immediately below the pavement, indicating a highly unstable base situation.

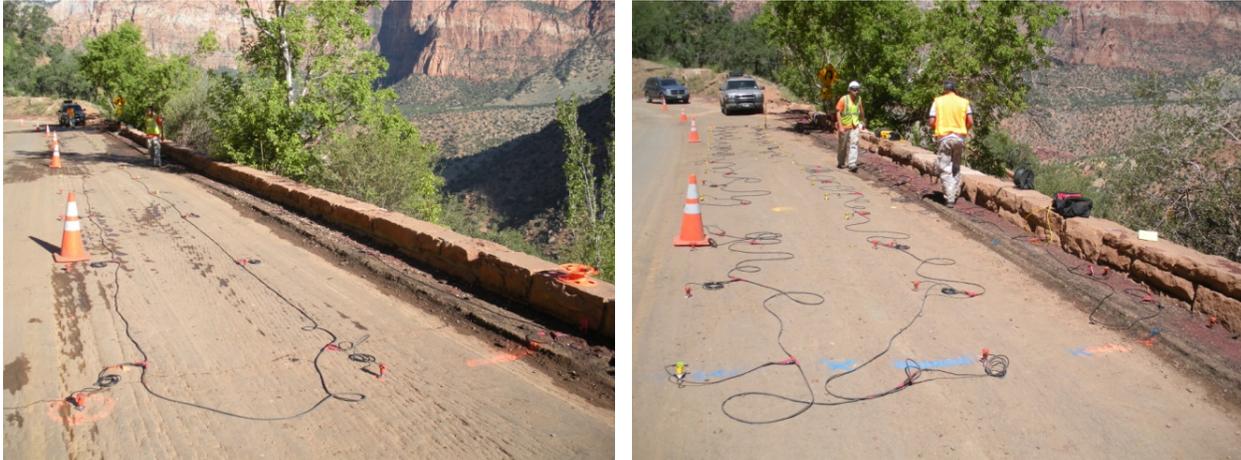
Figure 4.3. Photo. Layouts of the (L) 10-ft (3-m) geophone spacing for grid #1 and (R) 5-ft (1.5-m) geophone spacing for grid #1 at Zion National Park, during pre-grouting seismic data collection.

lines of sixteen geophones, with an intermediate line of geophone locations was established 6 ft (1.8 m) between the first and third lines.

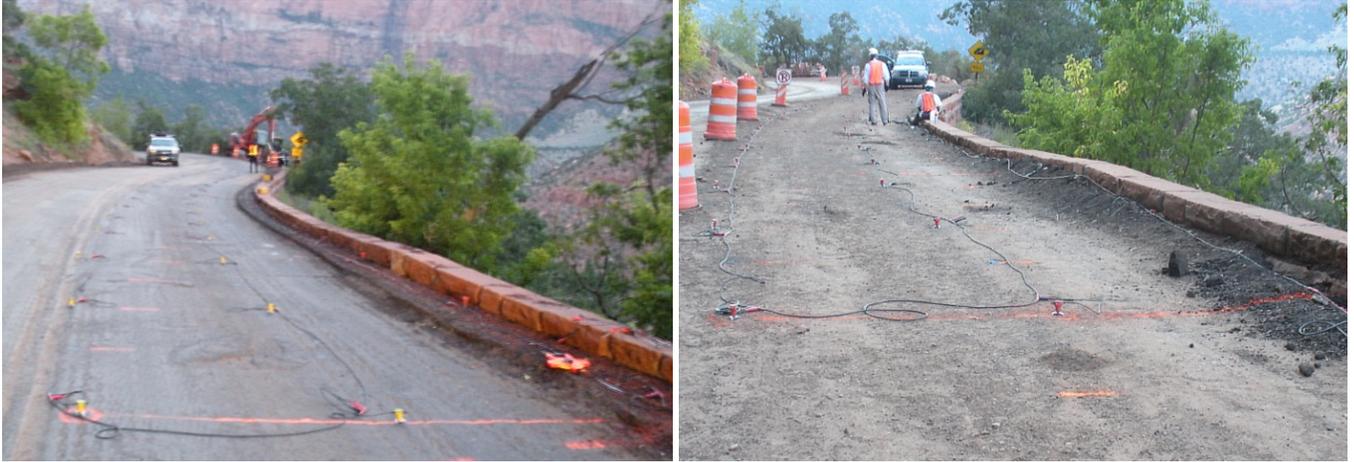
Figure 4.4. Photo. Layout of the 10 ft (3.0 m) geophone spacing at Zion National Park, grid #2 during (L) pre-grouting and (R) post-grouting seismic data collection.

The layout for the second grid was more complicated than the first, due to the curved alignment of the roadway at the selected location. While the first survey location was along a fairly straight roadway segment, the second was located along a curve. Similar procedures were followed, with more care taken to record and lay out geophones and sourcing locations. A rectangular grid was established following the same procedures as those used for the first survey location, with distances to grid corners recorded based on the control points established and known fixed features at the site. Parallel lines were then marked every five feet in the x-direction along this grid. Geophones were then set up along a pattern that maintained either a 5- or 10-ft x-direction spacing, depending on the grid being surveyed, but the y-coordinates varied for each x-coordinate depending on the alignment of the roadway at that location. In other words, each geophone at a given x-coordinate was translated by the same distance in the y-direction, maintaining equal spacings of 6 feet in the y-direction as those used in the first grid layout. The single 10-ft in-line geophone layout and two 5-ft in-line geophone layouts were referred to as layouts 2.10, 2.5.1, and 2.5.2 for grid #2, following the same naming convention used for grid #1. Diagrams illustrating these layouts can also be found in Appendix B, and Figure 4.4 shows the curved alignment of the grid #2 and geophone layout for the 10-ft (3-m) geophone spacing.

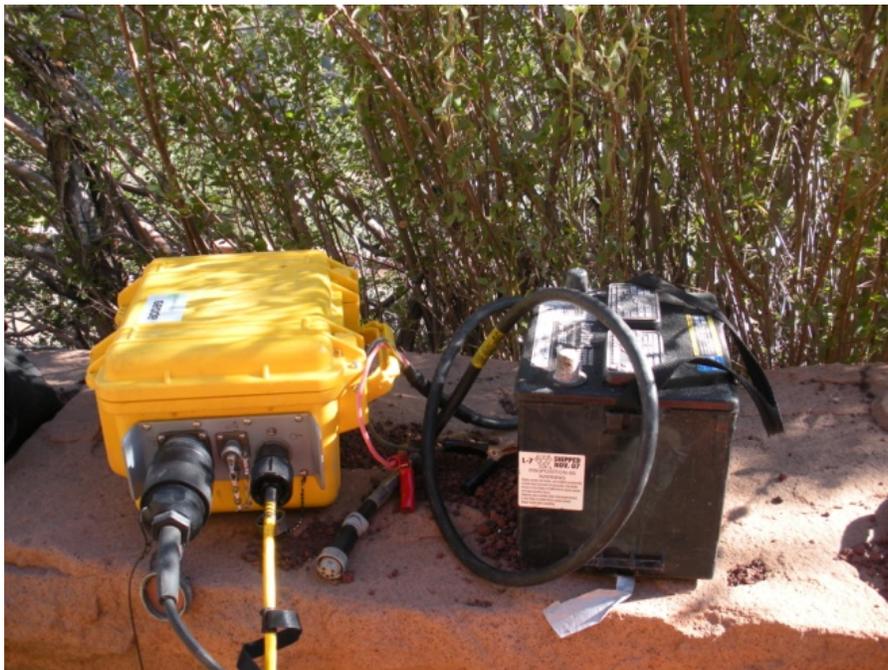
Figure 4.5. Photo. Twenty-four channel Geometrics Geode seismograph.

Two 24 channel geode seismographs manufactured by Geometrics of San Jose, California were used to collect and process the information received from the geophones, as shown in Figure 4.5. Each of the seismographs was powered by a 12V automotive battery, and data output was recorded using a ruggedized laptop PC. Built into the seismograph operating software are signal observation tools to monitor each geophone, which was used to verify satisfactory operation of each geophone and recording of synthesized noise prior to data collection.

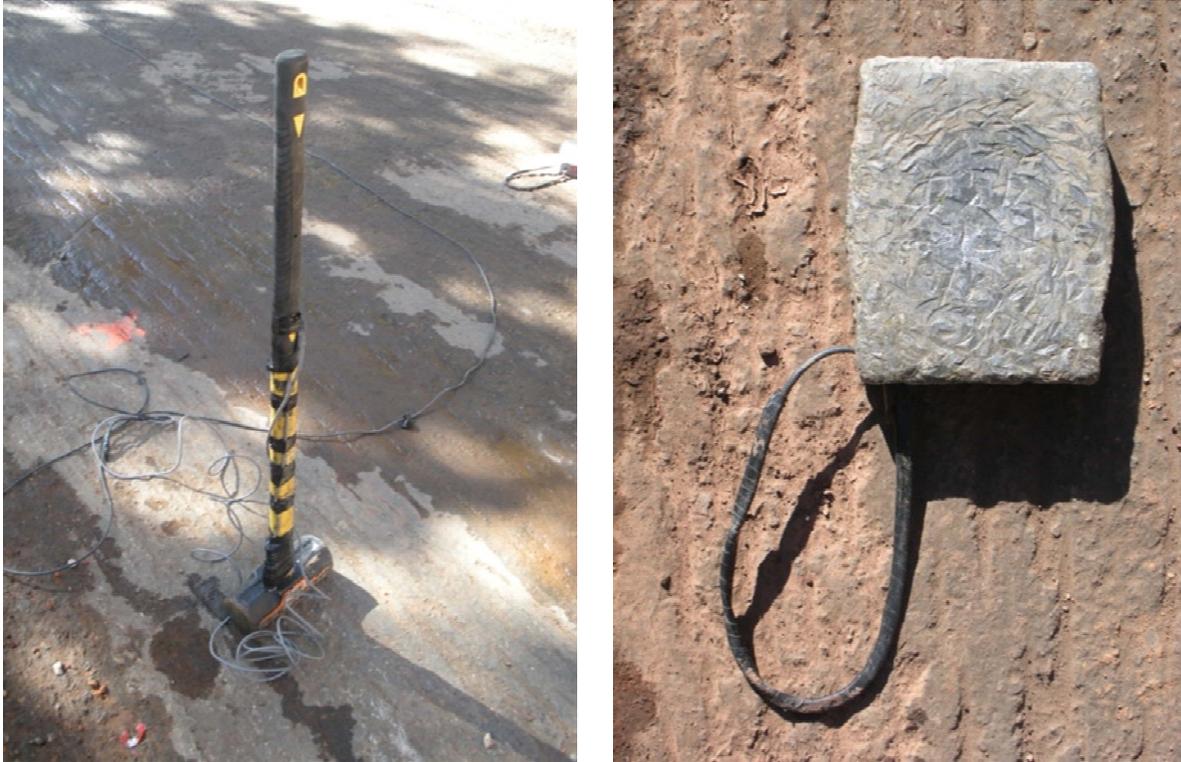
Figure 4.6. Photo. (L) Sledge hammer; and (R) aluminum strike plate.

A 12 lb. sledge hammer equipped with a “triggering” device was used as a seismic source. The hammer was impacted upon an aluminum plate, both shown in Figure 4.6, with sufficient energy to produce good quality readings at every geophone, as determined by the contracted geophysicist. The trigger sent a signal to the data recorder to begin recording as soon as impact occurred. Shot records recorded by the seismograph were stored to the laptop hard drive, which were later transferred to another system for first arrival picking and tomographic analysis.

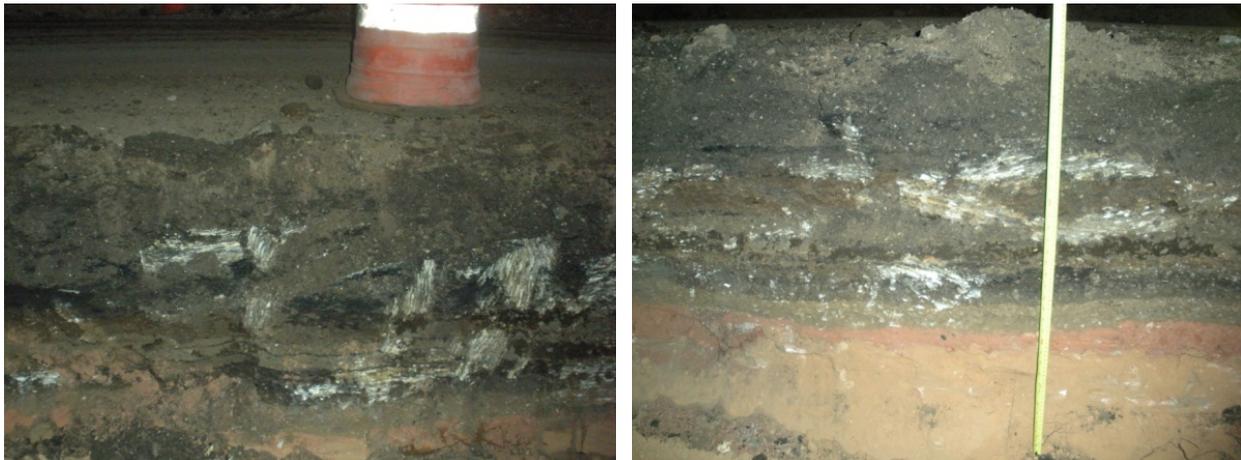
Figure 4.7. Photo. Asphalt thickness greater than 1 m (3 ft) observed at Zion National Park, site due to repeated maintenance patching to correct settlement.

At one of the segments being studied as part of the geophysical investigation, the excavation had been completed the night before we arrived, allowing some photographs to be taken and observations to be made. Perhaps most interesting about the excavation was the very deep areas of asphalt pavement that remained visible even after milling and 3 ft (1 m) of excavation. Greater than 2-ft (0.6-m) asphalt thicknesses were present at the centerline, increasing toward the stone wall, as shown in Figure 4.7. These observations were postulated to have the unexpected result of showing decreases in p-wave velocities for the reinforced fill zones once the post-grouting geophysical survey is performed. Nuclear density testing logs for the compacted fill placed at this location show placed wet densities ranging from 138 to 145 lb/ft³, at moisture contents of between 5.4 and 6.2%. Fill was placed in the excavation in 9 inch lifts separated by geotextile fabric as specified in the plans with multiple passes of a smooth drum vibratory roller compactor.

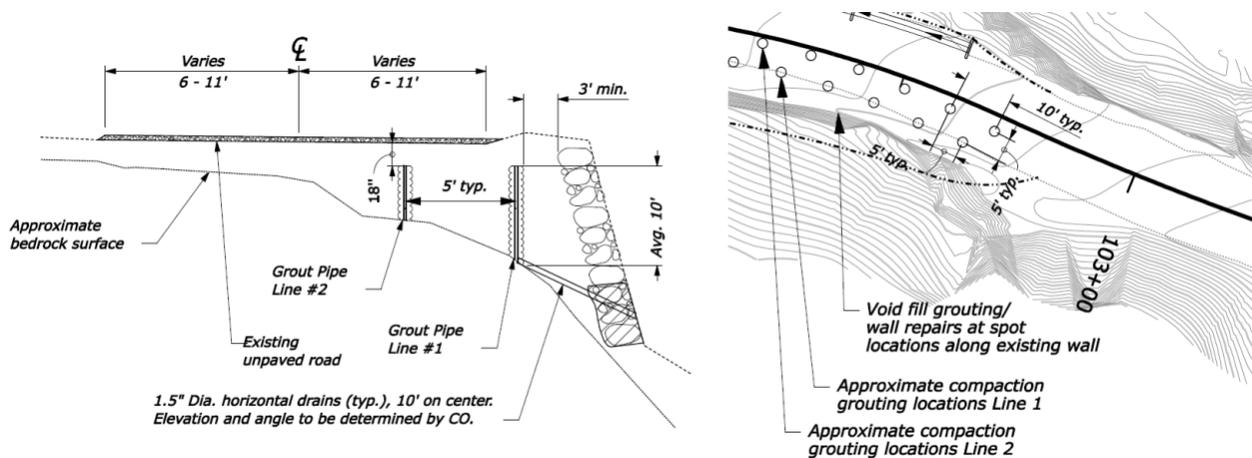
Figure 5.1. Schematic. Typical grouting profile and layout at Apache Trail Wall 1.

While traditional high-pressure, low-slump compaction grouting was originally specified in the plans as the primary method of filling potential voids and densifying zones of loose soil, concerns about possibly damaging the historic dry stacked retaining walls necessitated the inclusion of strict monitoring criteria, particularly for displacement of the wall faces and the maximum allowable grouting pressure. Similarly to the grouting at Zion National Park, casings were installed to relatively shallow depths from 2 to 17 ft (0.6 to 5.2 m). The first several holes that were attempted to be grouted using the compaction grouting technique were quickly advanced upstage without taking significant grout quantities. Following some changes, the greatest results were obtained by increasing the water-cement ratio of the grout and filling the holes strictly by gravitational pressure, or hydraulic head. A water to cement ratio of 0.77 by weight (1.17 by volume) was chosen, along with an equal weight of fly ash to cement, to which small amounts of retarding and thixotropic admixtures were added. Figure 5.1 provides a typical construction detail for the compaction grouting layout, and Table 5.1 summarizes grouting quantities.

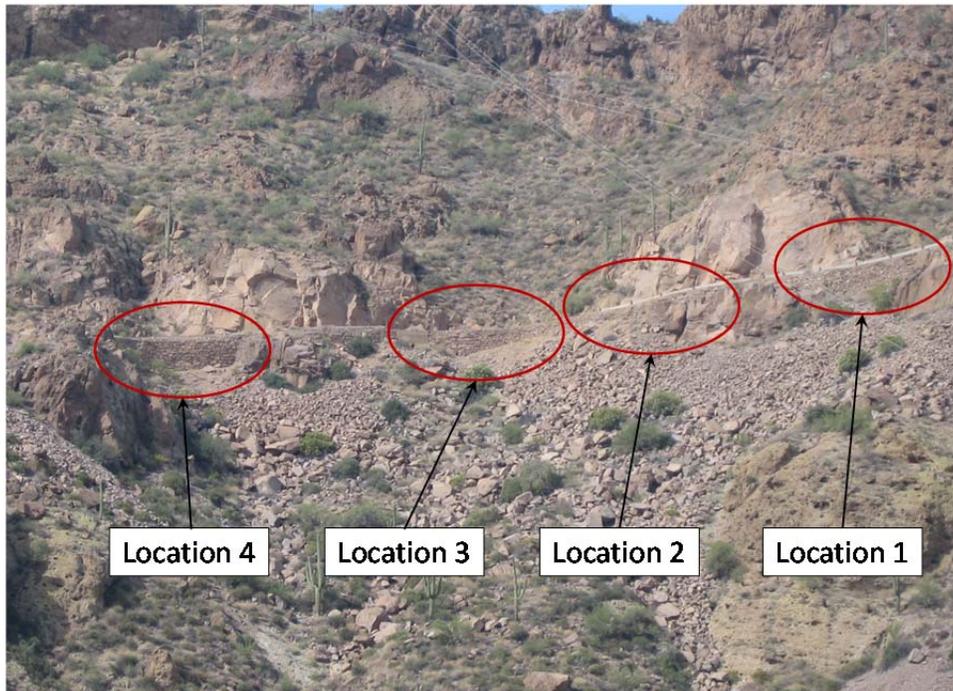
Figure 5.2. Photo. Panoramic photograph showing locations 1 to 4, from right to left, along Wall 3 at Apache Trail, with stationing advanced from approximately 300+00 at the right to 304+50 at the left.

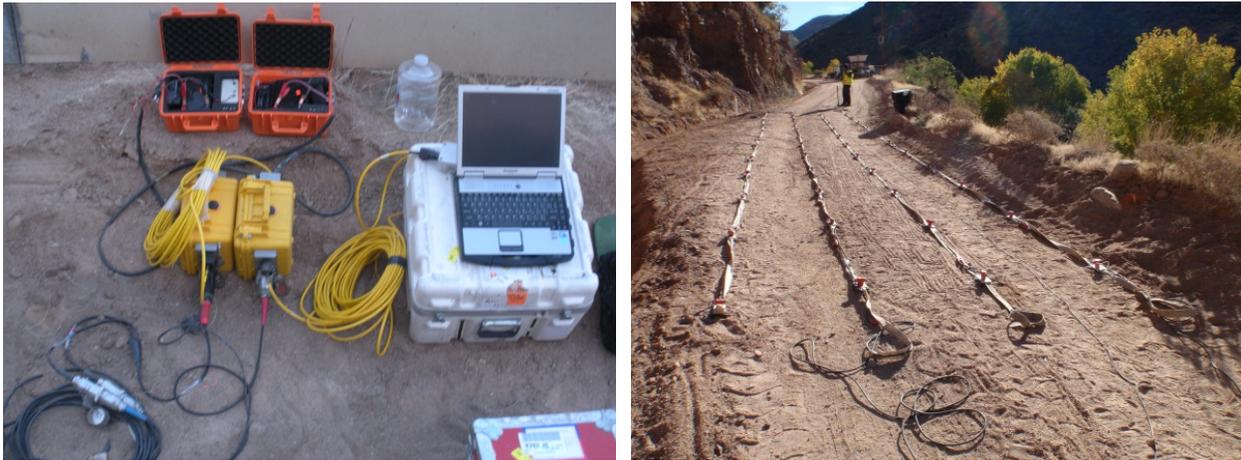
Figure 5.4. Photo. (L) Laptop, seismograph, and battery setup; and (R) geophones deployed on landstreamers at Apache Trail.

Due to the relatively shallow depths to bedrock at both sites and the close spacings of geophones, arrival times were relatively small. In these situations, the addition of a delay, or pre-trigger geophone signal record, provided a longer baseline signal to consider during data interpretation and resulted in easier to distinguish arrival times. The use of geophone tripod bases and landstreamers with geophones mounted to baseplates both allowed for successful identification of compression wave arrival times, often without requiring shot stacking. Background noise from nearby construction activities during data collection was addressed by stacking consecutive shot records from the same location when noise became significant.

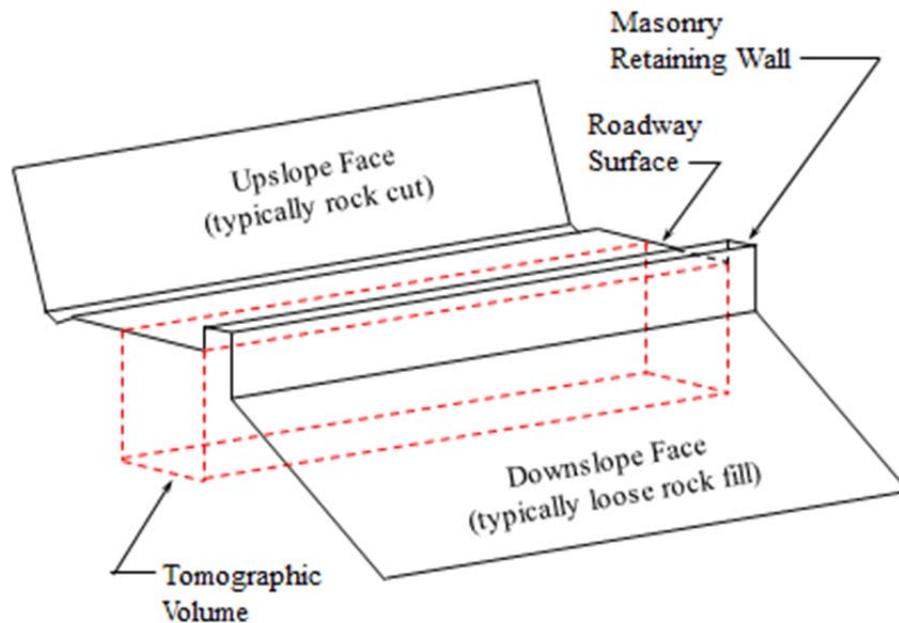
Figure 6.1. Schematic. Schematic illustrating the viewing perspective for the tomography generated for both Zion National Park, and Apache Trail sites, relative to the typical site conditions.

Figure 6.1 provides a schematic which helps orient the viewer as to the perspectives given for all tomography developed for this study. While different origins and directions of coordinate axes were chosen for the Zion National Park and Apache Trail relative to the adjacent retaining walls at the sites due to conditions in the field, the viewing perspective for the tomography is maintained consistently throughout this report with respect to viewing angle. This allows the viewer to better understand the conditions nearer to the retaining wall structures, which were of primary concern when performing grouting at these sites. Additionally, the most severe signs of settlement and roadway damage were observed along the outboard traffic lanes at these sites, which correspond to the nearer side of the tomography as presented here.

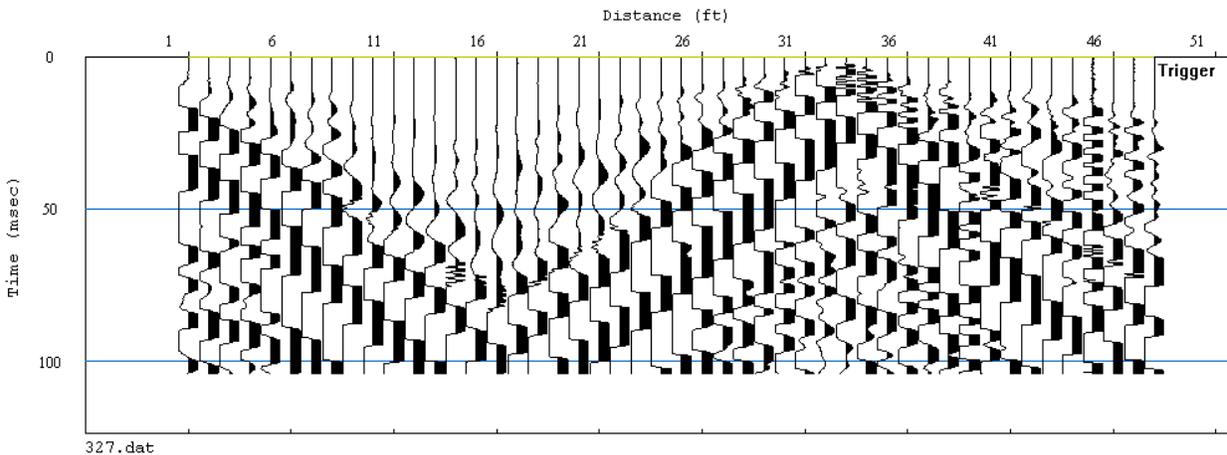
Figure 6.2. Graph. Typical shot record for 3D layout 2.5.1 at Zion National Park, with clearly distinguishable first arrivals.

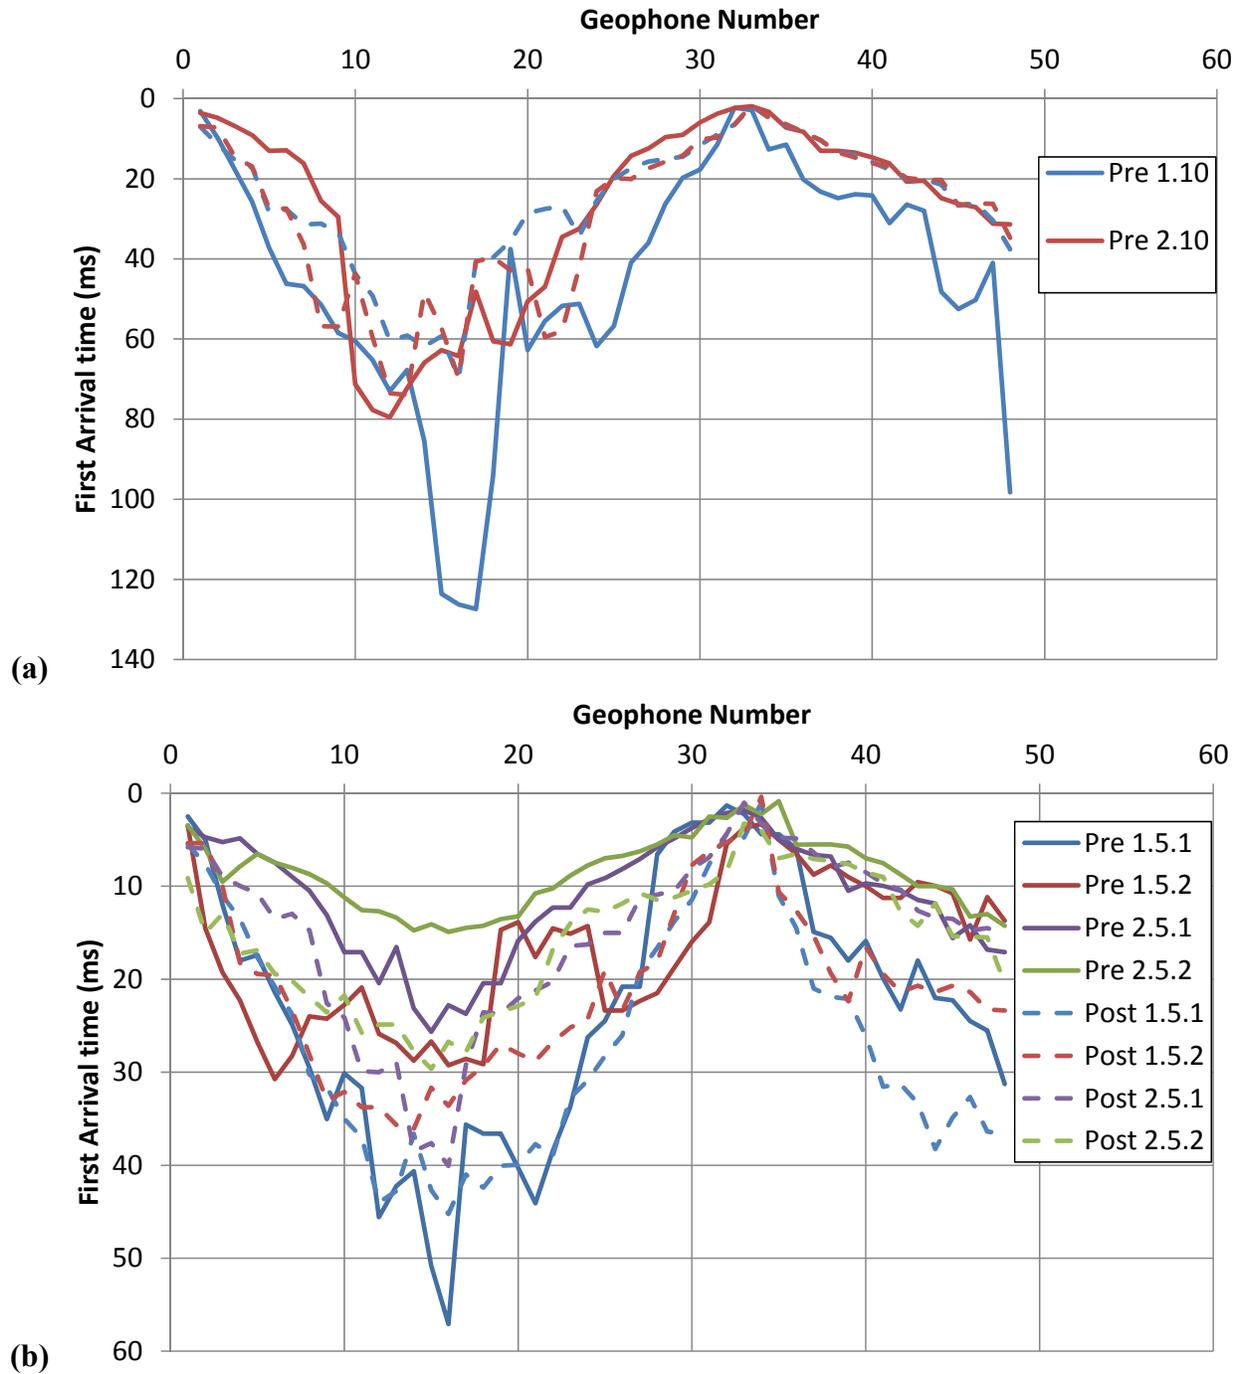
Figure 6.3. Graph. Manual training picks used for GSR3D autopicker for Zion National Park sites: (a) 10-ft (3-m) geophone spacing; and (b) 5-ft (1.5-m) geophone spacing.

Figure 6.3 shows overviews of the training picks used for generation of the 3D seismic tomography at the Zion National Park sites. A general trend can be observed in this figure, where significant increases in arrival times occurred following grouting for the 5-ft (1.5-m) geophone spacings, which may have resulted from decreases in seismic velocities following grouting. The opposite trend is generally observed for the 10-ft (3-m) geophone spacing layouts, where decreases in arrival times can be noted, which would suggest increased seismic velocities within the subsurface materials. It should be noted, however, that due to the circumstances encountered during data collection, as previously mentioned, the locations of shots and geophones for both grids were not able to be maintained completely between the pre- and post-grouting surveys, but the relative locations used for the training shots were held consistent.

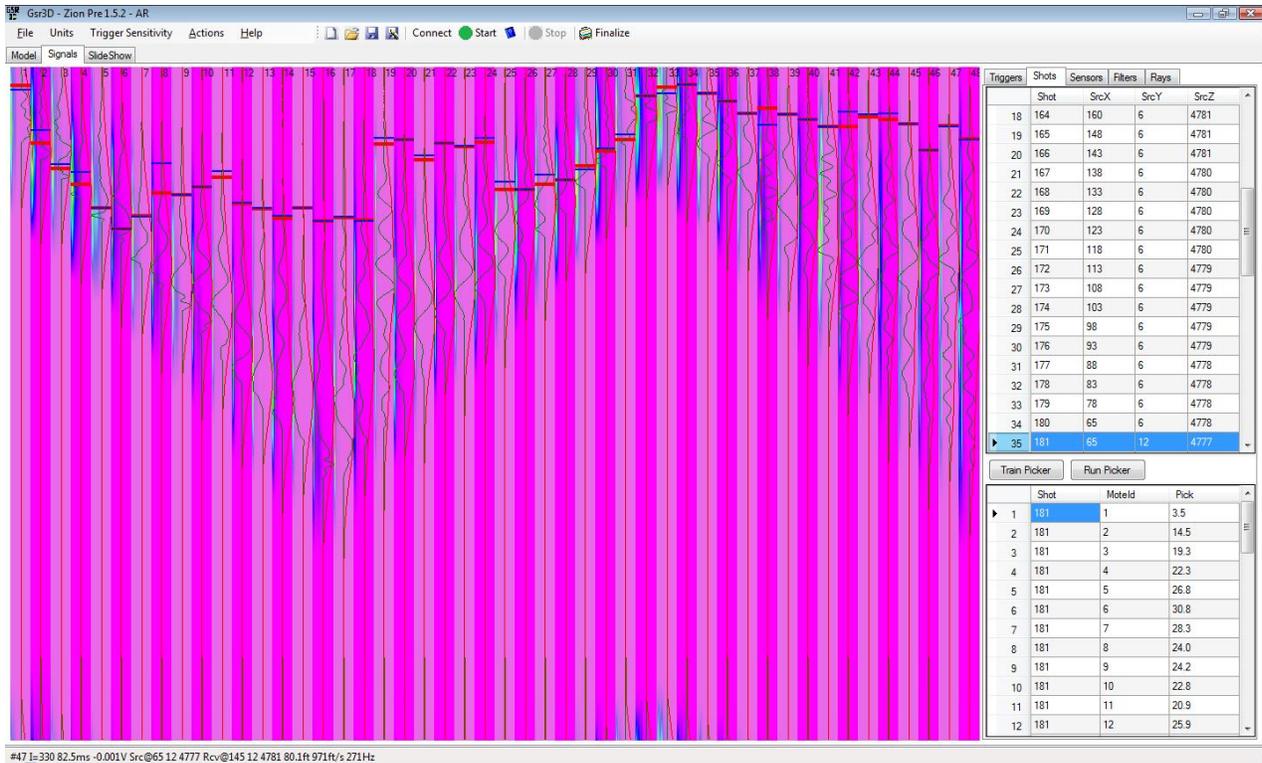
Figure 6.4. Screenshot. Typical GSR3D screenshot showing manual training picks (in red) and resulting trained autopicks (in blue) used processing of seismic data for Zion National Park pre-grouting location 1.5.2.

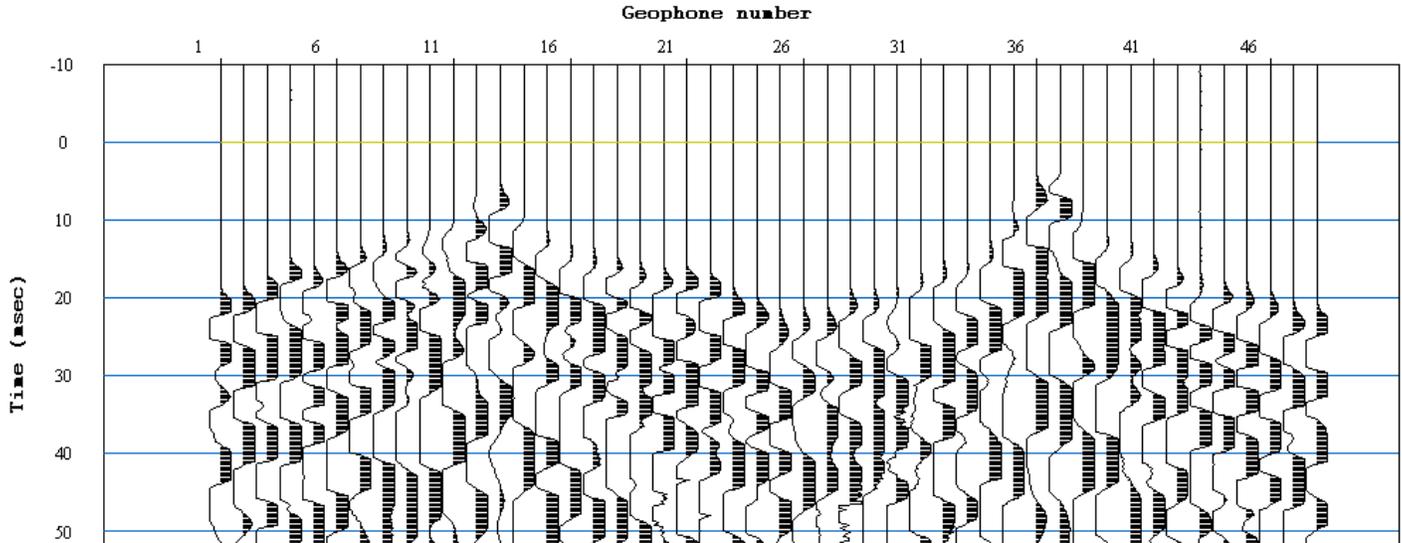
Figure 6.5. Graph. Typical shot record for 3D layout at Apache Trail, with clear first arrivals and pre-trigger delay interval shown.

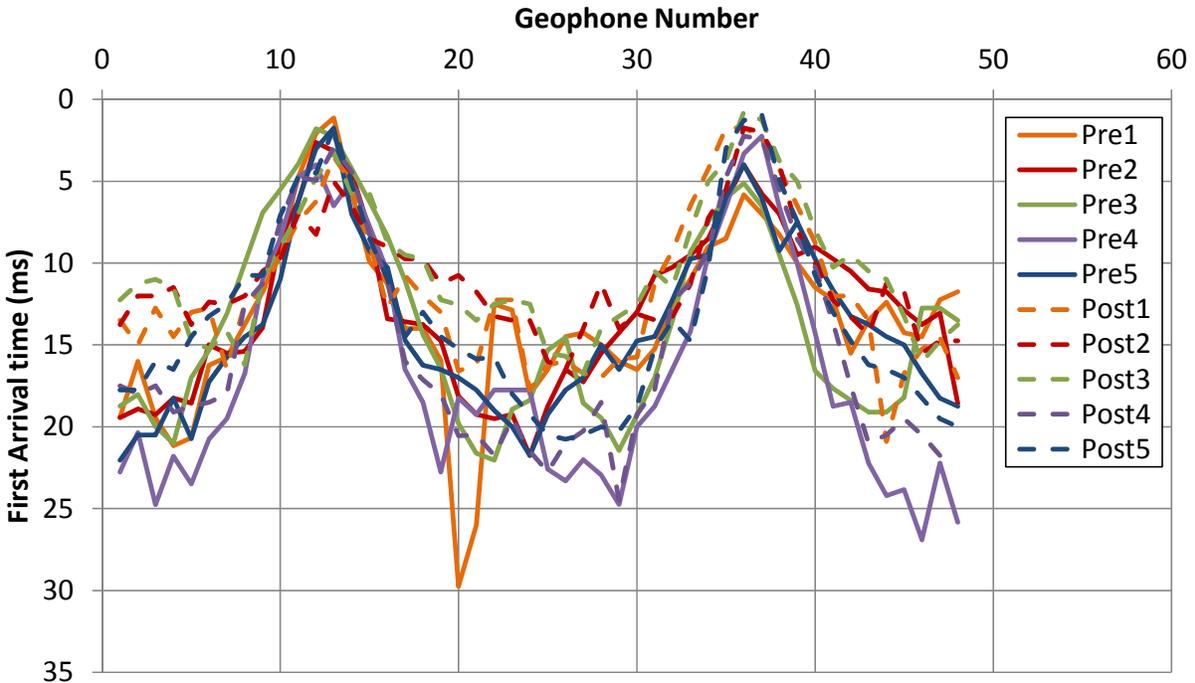
Figure 6.6. Graph. Manual training picks used for GSR3D autopicker for Apache Trail sites.
