VERIFICATION OF GROUTING Using 3D Seismic Tomography

Publication No. FHWA-CFL/TD-11-007

September 2011

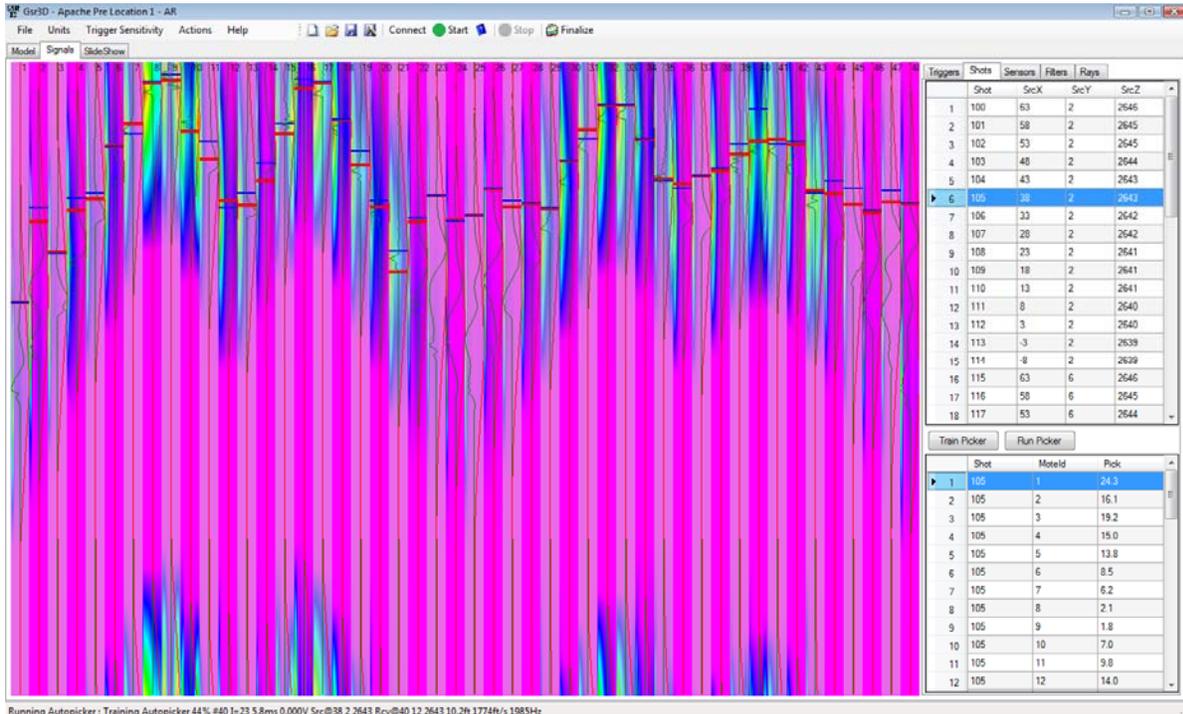
Figure 6.7. Screenshot. Typical GSR3D screenshot showing manual training picks (in red) and resulting trained autopicks (in blue) for Apache Trail pre-grouting location 1.

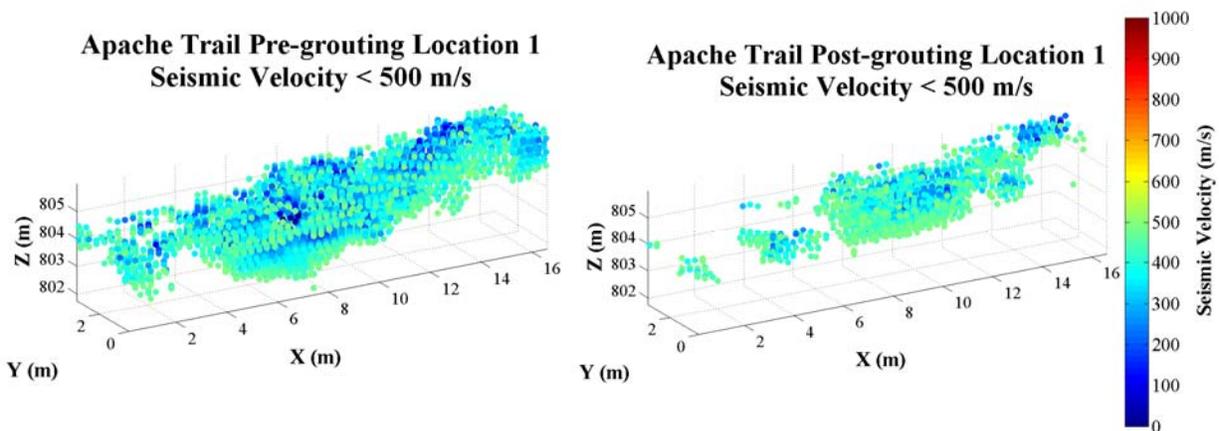
Figure 7.1. Graph. Pre- and post-grouting tomography for Apache Trail Location 1, showing data points having seismic velocities less than a targeted velocity of 500 m/s.

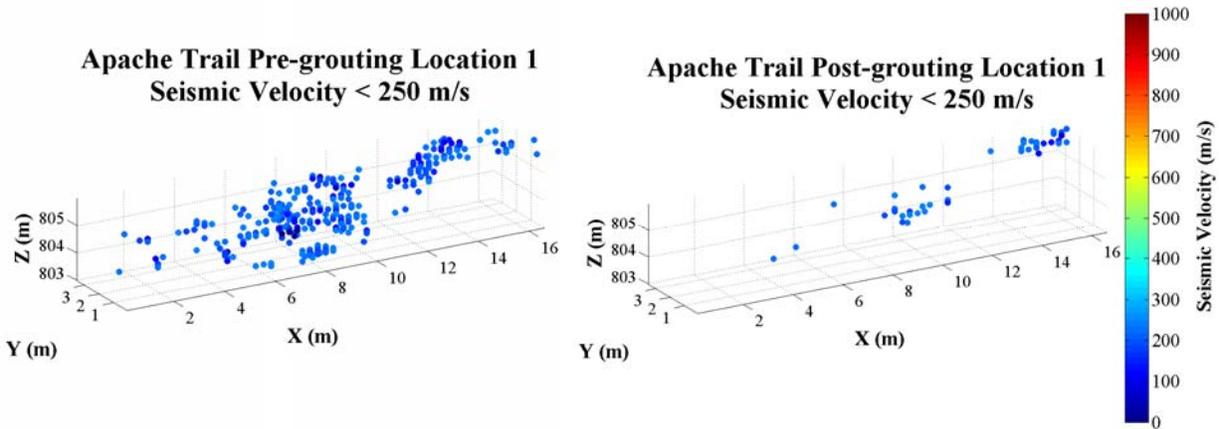
Figure 7.2. Graph. Pre- and post-grouting tomography for Apache Trail Location 1, showing data points having seismic velocities less than a targeted velocity of 250 m/s.

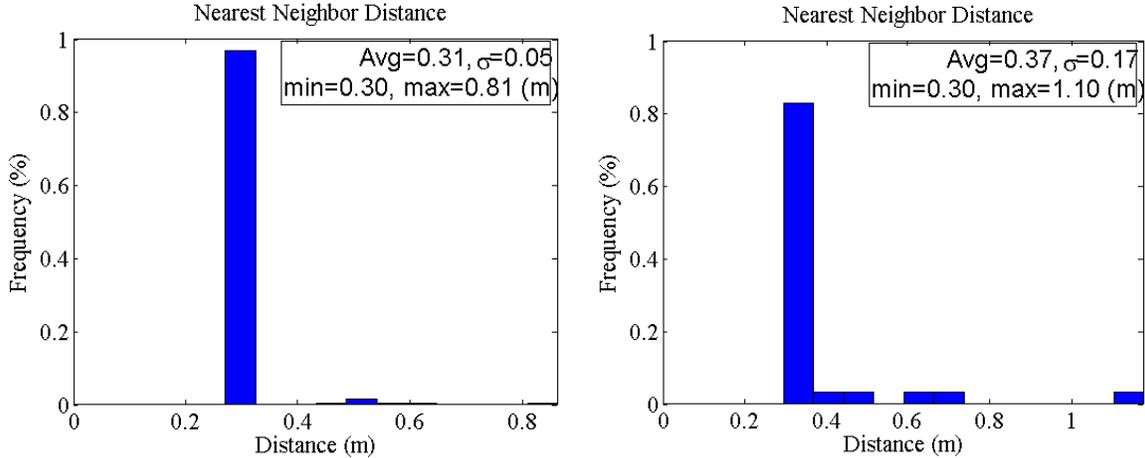
Figure 7.3. Graph. Nearest neighbor distance plots for Apache Trail Location 1 pre-grouting (left) and post-grouting (right) for seismic velocities less than 250 m/s.

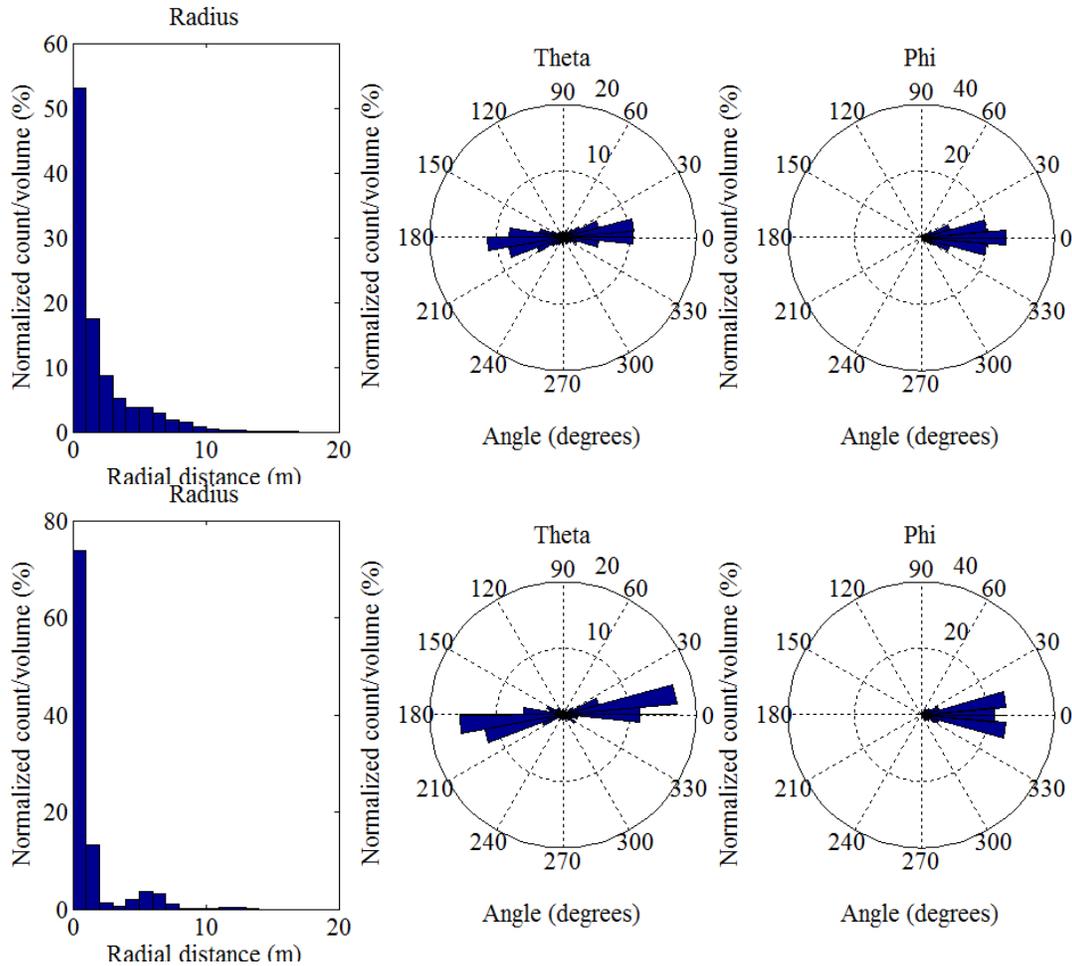
Figure 7.4. Graph. Tri-histogram plots for Apache Trail Location 1 pre-grouting (upper) and post-grouting (lower) for seismic velocities less than 250 m/s, showing a closer packing of points following grouting.

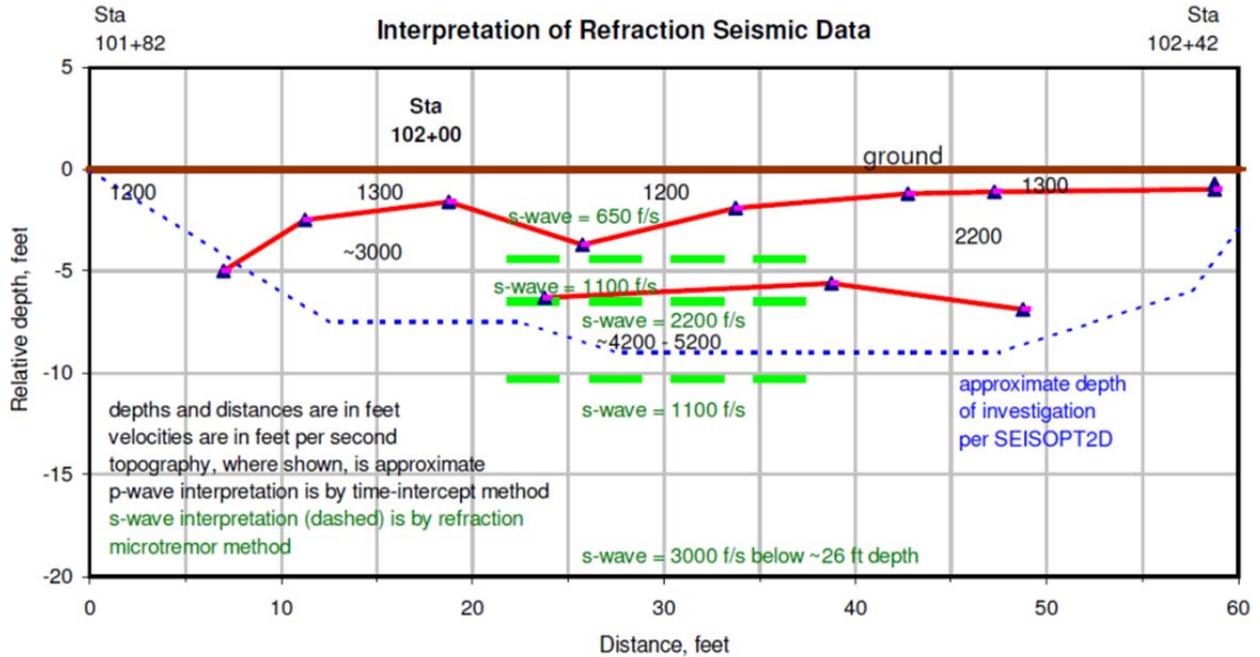
Figure 7.5. Schematic. Results from 2D seismic refraction analysis for Line 4 at Apache Trail, as performed previously by AMEC (2007) using SeisOpt2D, which corresponds to Location 5 of the 3D tomography study performed here.

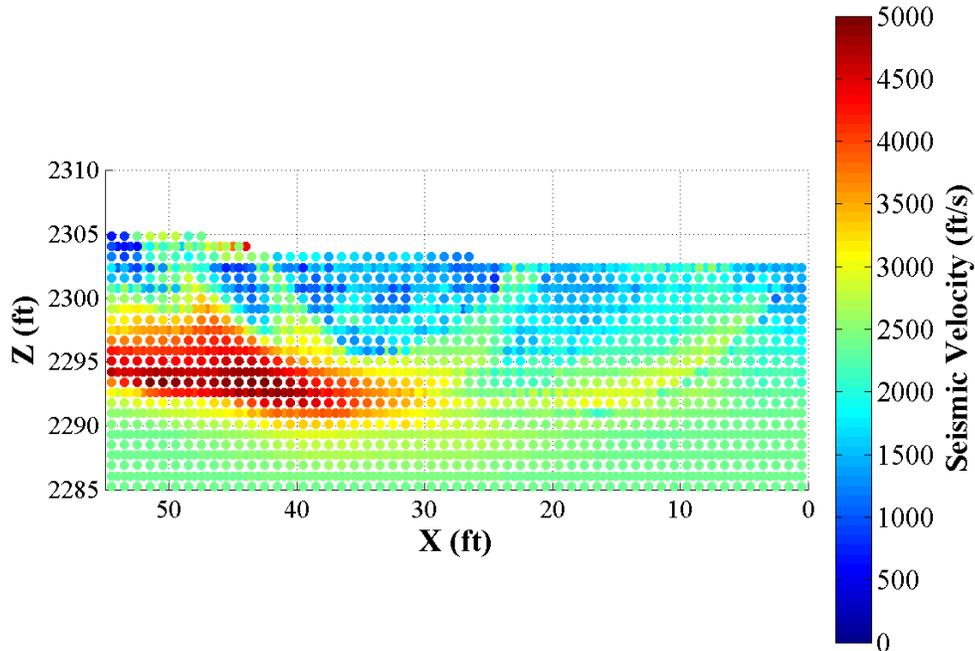
Figure 7.6. Graph. 2D slice of 3D seismic tomography results from Apache Trail Location 5, shown in the same orientation as the results from the 2D refraction survey. Slice shown for values of $-1 \text{ ft} < y < 1 \text{ ft}$ ($-0.3 \text{ m} < y < 0.3 \text{ m}$).

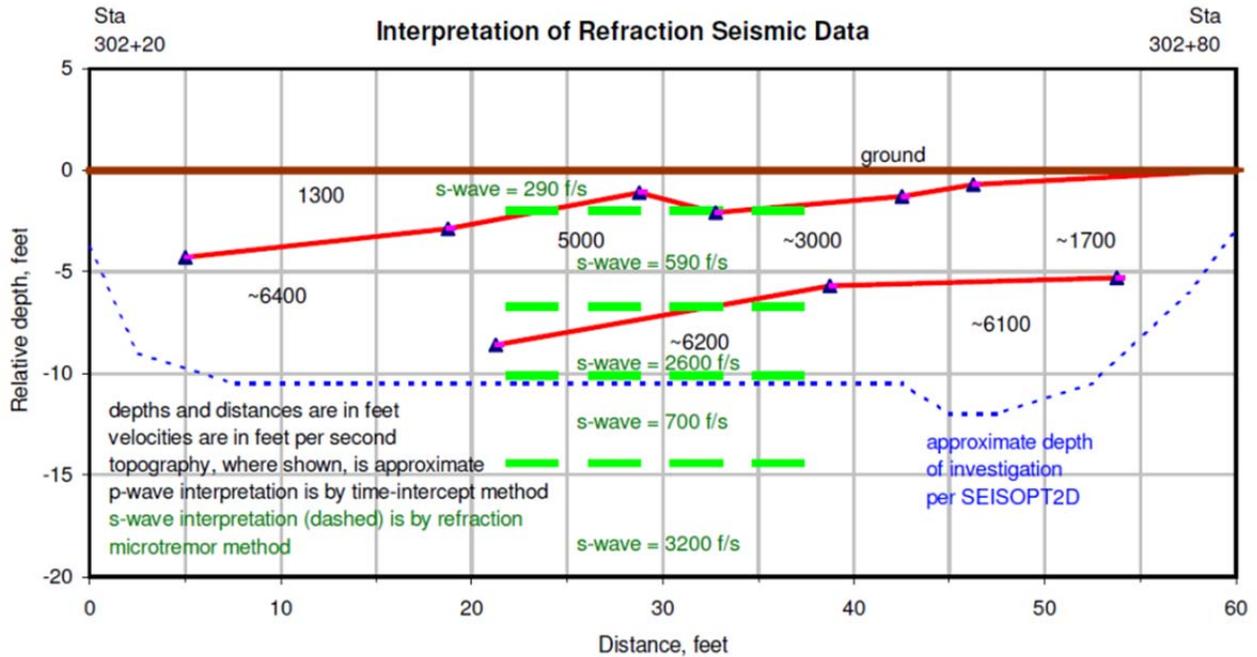
Figure 7.7. Schematic. Results from 2D seismic refraction analysis for Line 8 at Apache Trail, as performed previously by AMEC (2007) using SeisOpt2D, which corresponds to Location 3 of the 3D tomography study performed here.

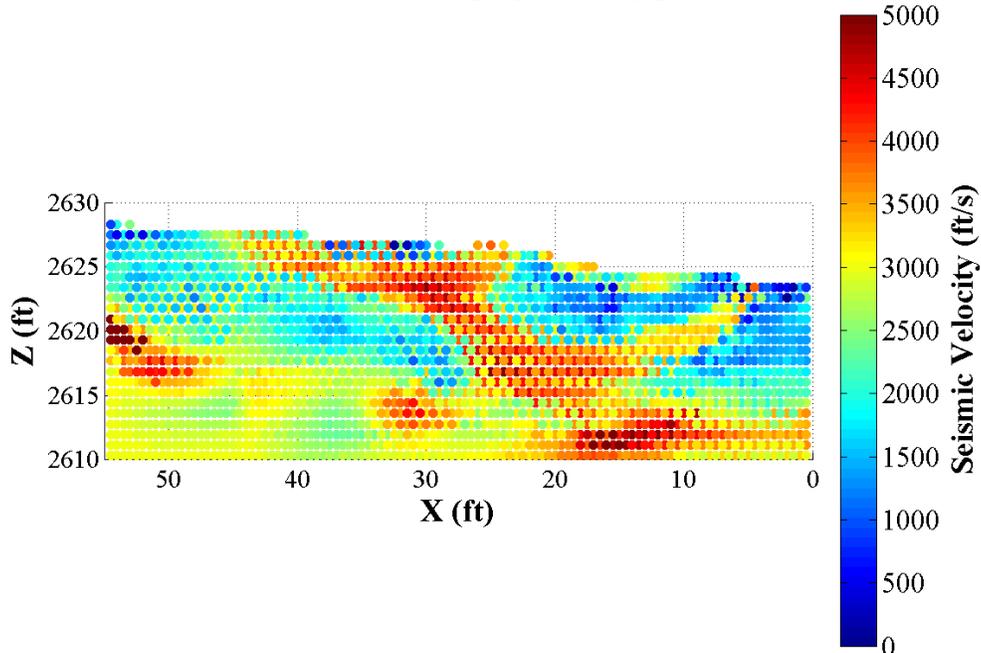
Figure 7.8. Graph. 2D slice of 3D seismic tomography results from Apache Trail Location 3, shown in the same orientation as the results from the 2D refraction survey. A slice is shown for values of $0 < y < 1.5$ ft ($0 < y < 0.5$ m).

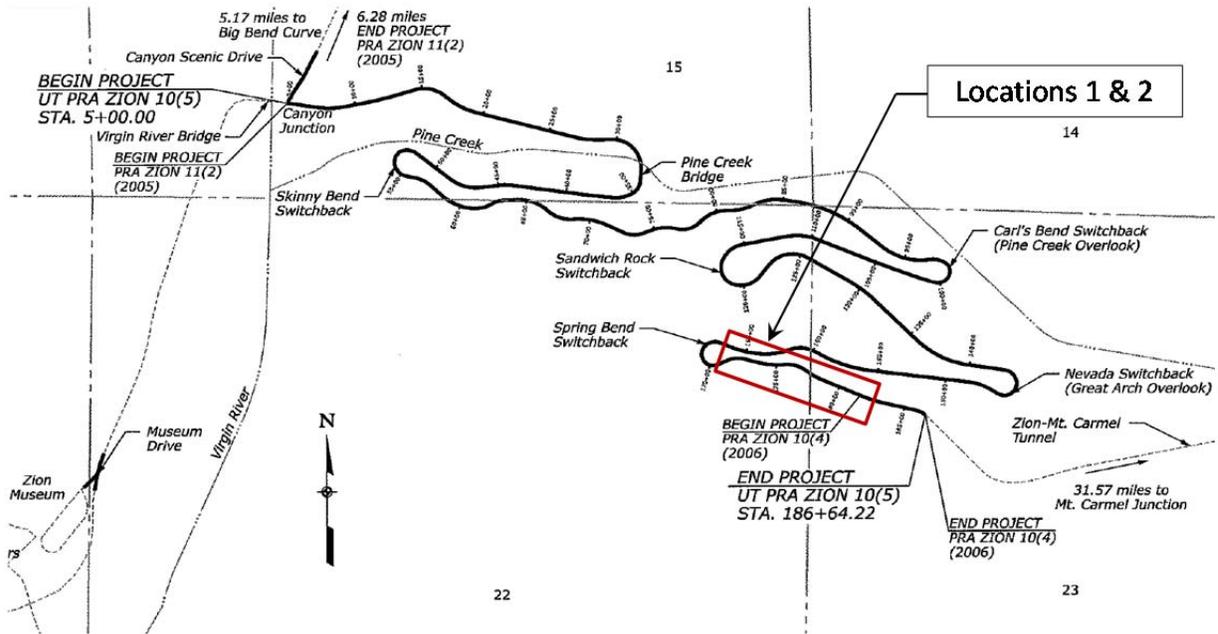
Figure A.3. Schematic. Plan drawing detail of Zion National Park project site.

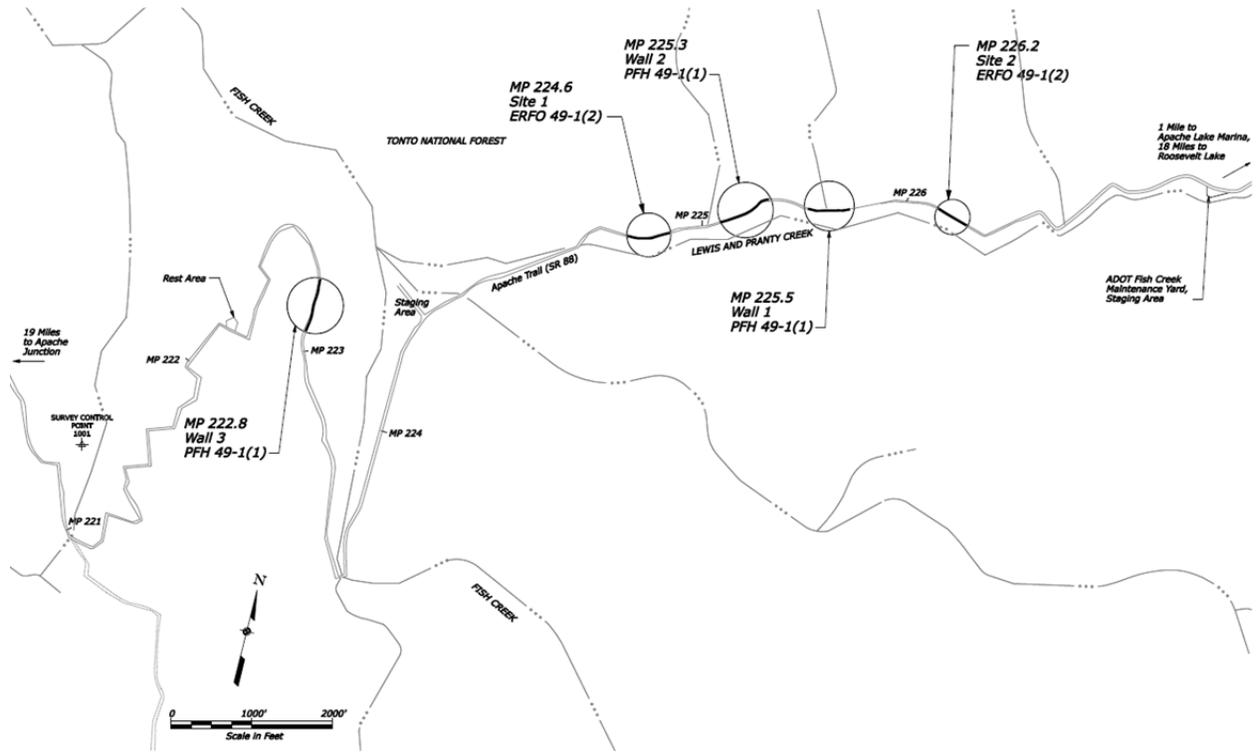
Figure A.5. Schematic. Plan drawing detail of Apache Trail project site.

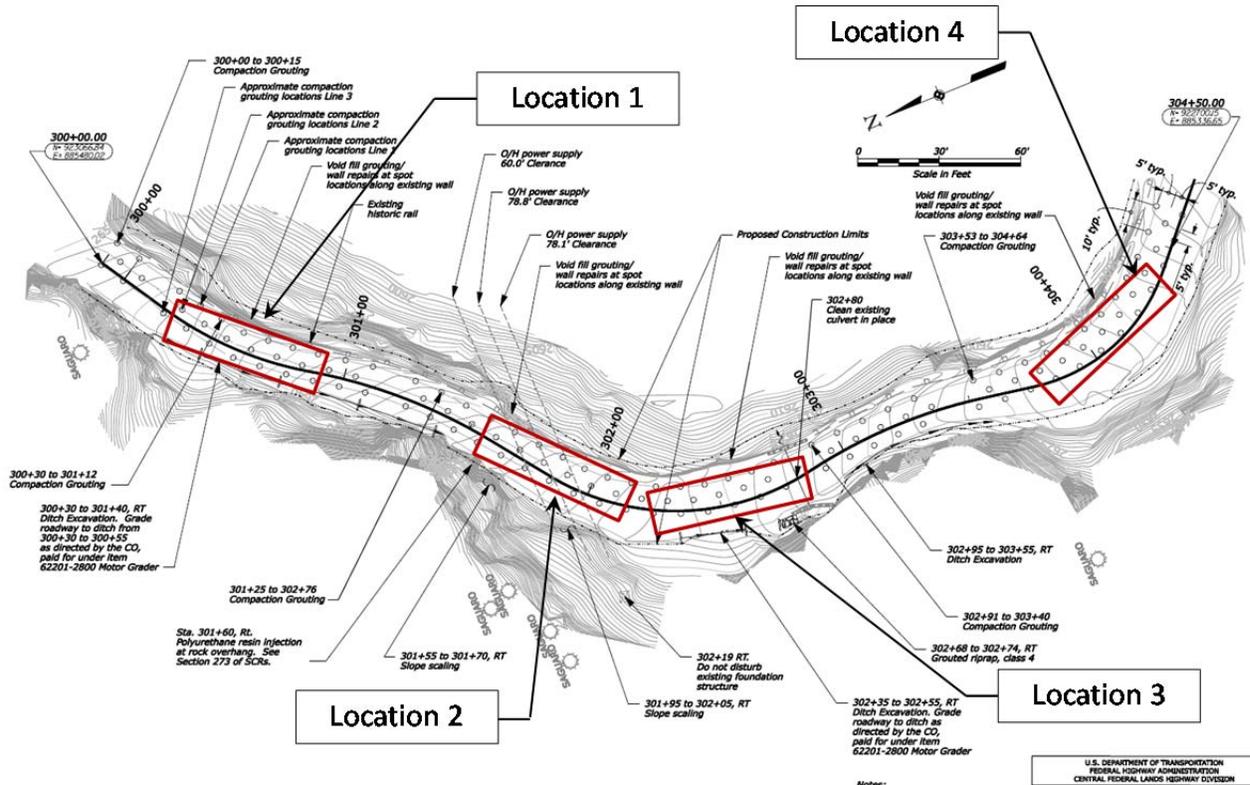
Figure A.6. Schematic. Plan drawing detail of Apache Trail Locations 1 through 4.

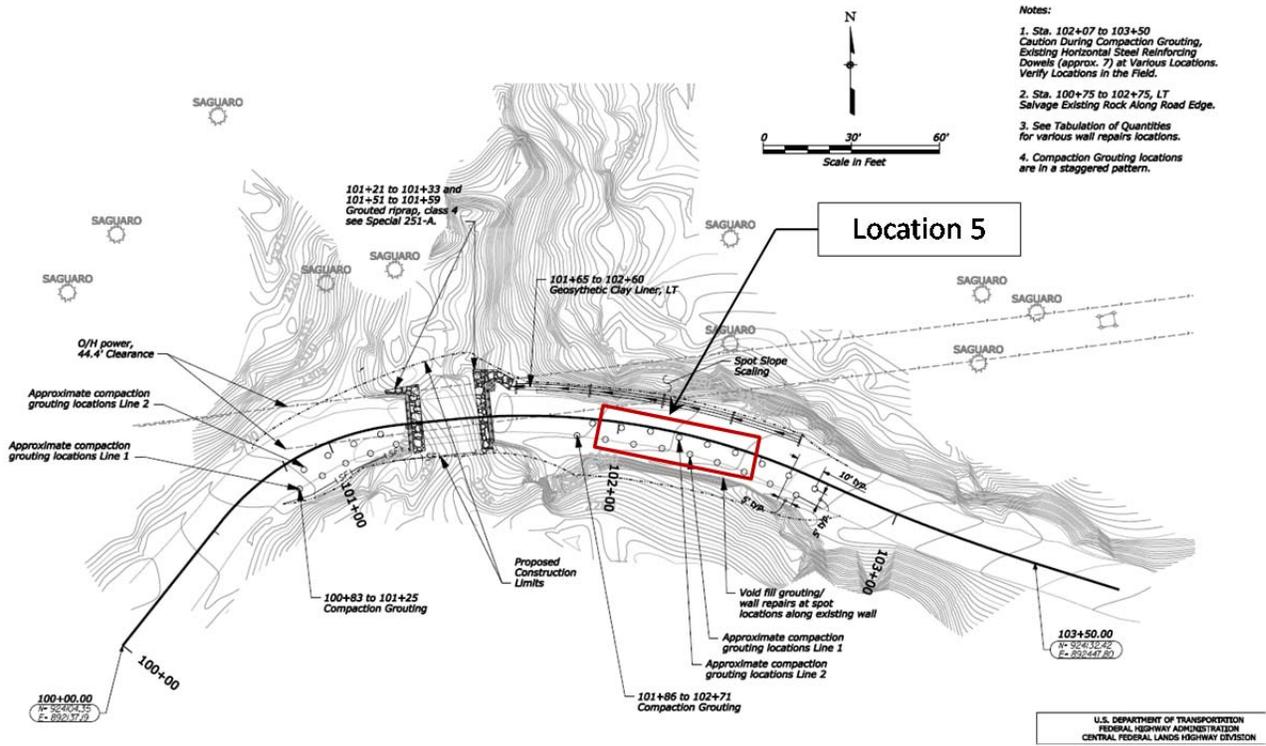
Figure A.7. Schematic. Plan drawing detail of Apache Trail Location 5.
