2012

Ridgefield Wildlife River 'S' Unit Access Bridge
Lake River Navigation Assessment

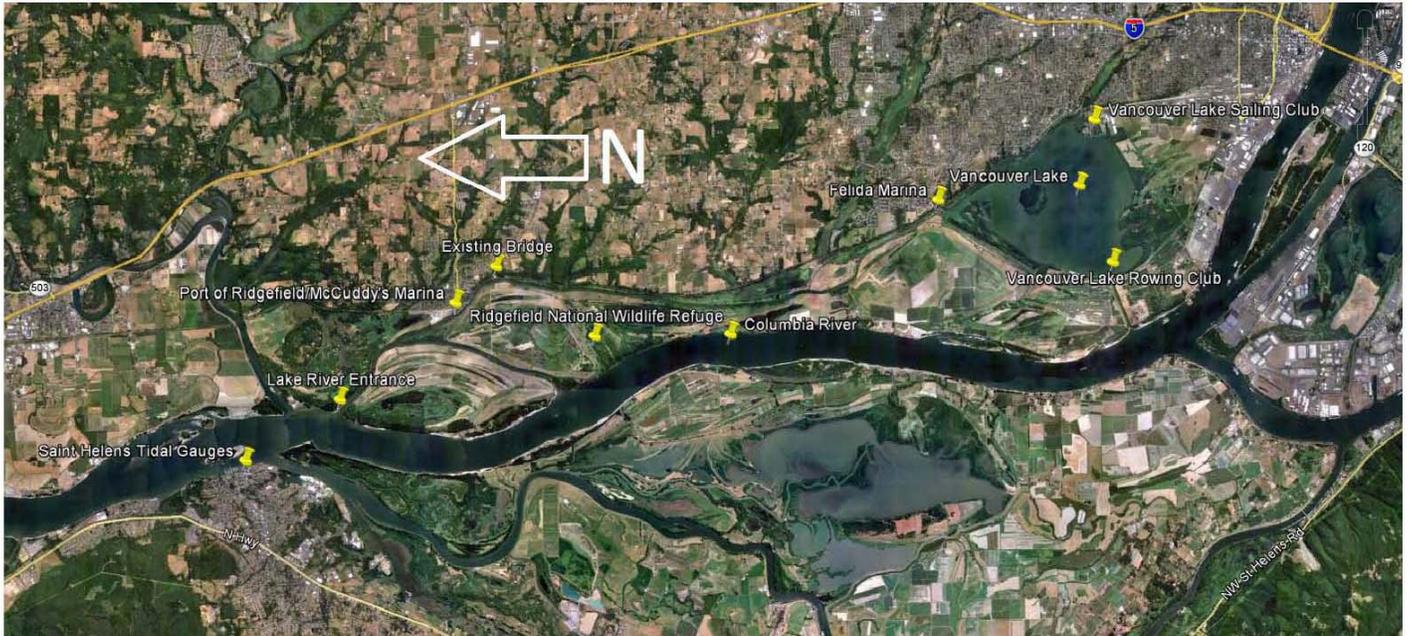
Figure 1. Aerial Picture of Area Surveyed (north is to the left)

Lake River originates from Vancouver Lake and flows from south to north, toward its juncture with the Columbia River. An aerial view is provided in Figure 1. The area surveyed in this study extends from the Lake River entrance to Vancouver Lake. The juncture of Lake River with the Columbia River is the origin for distance measured along the axis of Lake River.

The aerial photos are from 2007 for McCuddy's Marina and 2011 for Felida, see Reference 1 and Reference 2. The Geographic Information System (GIS) data is from a 2005 LiDAR survey, Reference 3 and Reference 4. The aerial photos were used to count and index the houseboats, as seen in Figure 2 and Figure 3. The houseboats were indexed from North (closer to Columbia River) to South (toward Vancouver Lake), and from West (toward Oregon) to East (toward Ridgefield/Clark County WA).

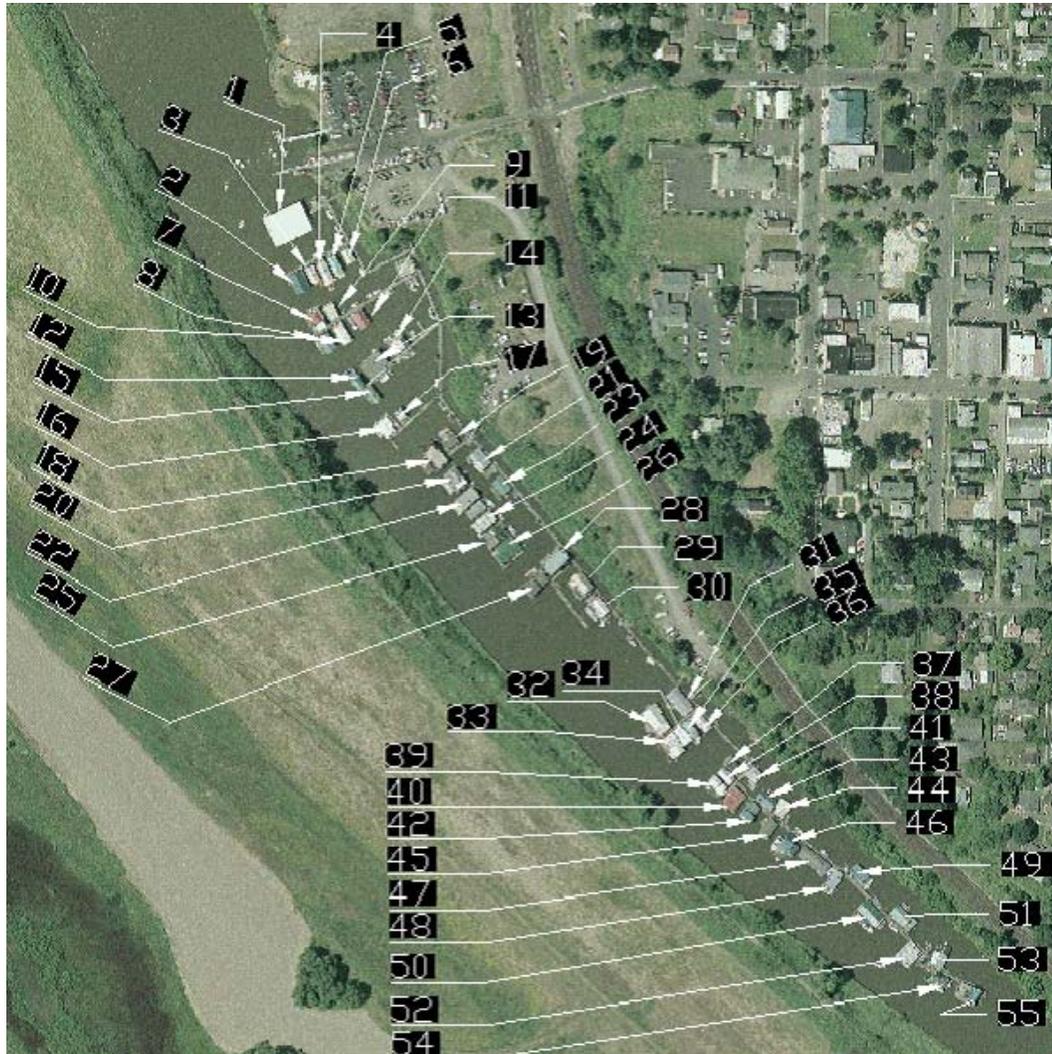
Figure 2. McCuddy's Marina

The houseboat indexing for McCuddy's Marina is seen in Figure 2. Fifty-five houseboats are identified from the Reference 1 aerial photography taken in 2007. During the field survey, the FHWA team had access to the entire length of the docks, but not permitted to board the houseboats and sailboats. However, houseboat owners were informed of the study by a letter prior to the verification work. When owners were present, permission to go aboard and obtain measurements with greater precision was requested. The survey team performed the study throughout the entire Marina.

Houseboats are indexed from north to south and labeled in Figure 2 and Figure 3, Section 2, Study Area Description. Dimensions presented are the maximum found from the on-site measurements.

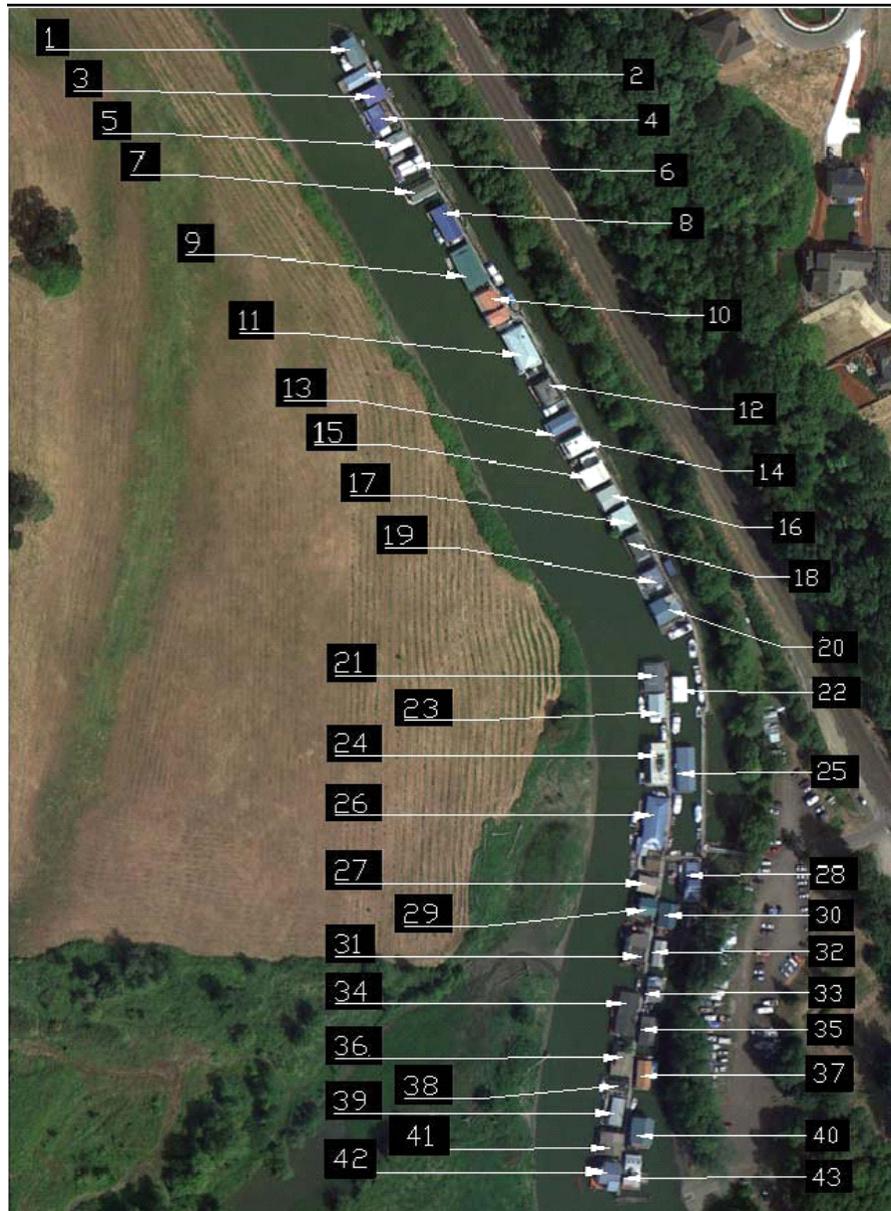
Figure 3. Felida Marina

The houseboat indexing for Felida Marina is seen in Figure 3. Forty three houseboats are identified from the Reference 2 aerial photography taken in 2011. During the field survey, the FHWA team had access to the entire length of the dock, but not permitted to board all watercraft. However, houseboat owners were informed of the study by a letter prior to the field verification work. Therefore, when owners were present, permission to go aboard and obtain measurements with greater precision was requested. The survey team performed the study throughout the entire Marina.

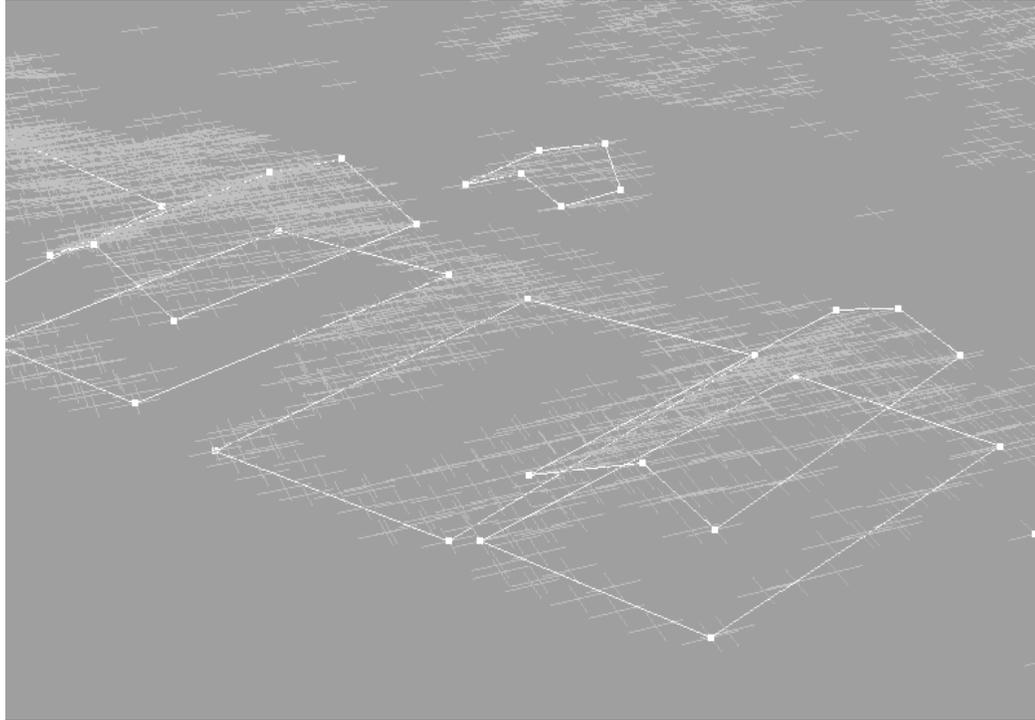
Figure 4 Bounding Box from TIN Control Points in Rhino3D

The GIS data collected in the LiDAR survey, Reference 3 and Reference 4, generated a triangulated irregular network (TIN). TIN control points were contained in Design Files. When the drawing was opened in Rhino, points representing the houseboats were visible. The highest and furthest apart points for each houseboat were identified. A bounding box for each houseboat was drawn between these points by connecting six points for the roof and four points for the base; see Figure 4. If the points selected were incoherent, they were

adjusted manually. Figure 4 is an example of the houseboat control point selection in Rhino.

The accuracy of the electronic data is approximately $\pm 1/2$ feet. The source of error comes primarily from the native accuracy of the GIS data, and the selection of 'points' to draw a bounding box around each houseboat. The bounding box provided the dimensions for maximum length, breadth, and height.

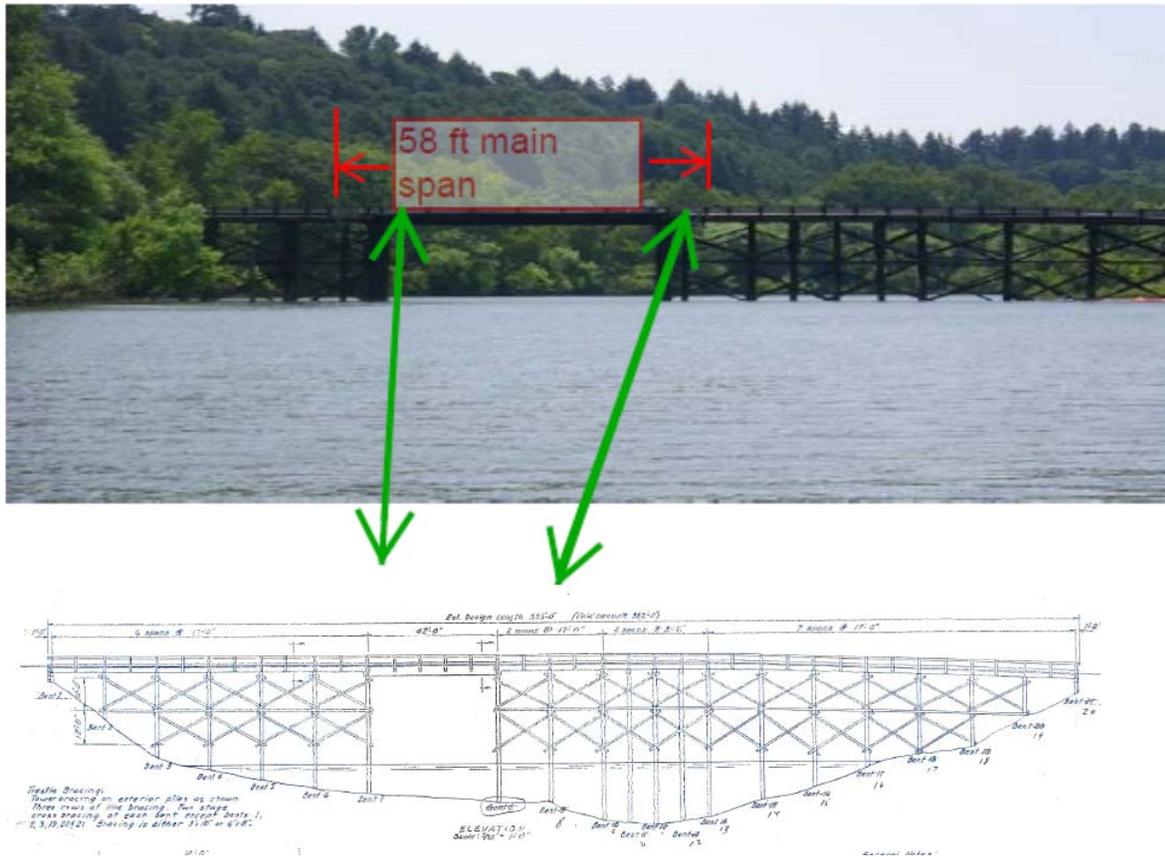
Figure 5. Existing Bridge

The 2010 Bridge Inspection and Appraisal Report, Reference 13, shows the vertical and horizontal bridge span clearance at 33 feet and 55.5 feet, respectively. The vertical reference datum associated with the 11 feet water level shown in Reference 13, from whence the 33 foot vertical clearance is determined, is not identified. The bridge’s horizontal navigation clearance was confirmed at 55.5 feet. Vessel traffic from, or destined to, upriver of the bridge must pass through the bridge span. The existing bridge is pictured in Figure 5.

Prior to 1981, the bridge had a 42-foot main span. Figure 5 illustrates the original bridge, and how the 42-foot main span was replaced by combining this span with an adjacent 16 foot span to create the new 58-foot span. This modification to increase the main span was at the request by a private contractor to the US Fish and Wildlife Service as a one-time-only removal and replacement to facilitate the dredging contract of Vancouver Lake at the expense of the private contractor.

The vertical distance between the bottom of the existing bridge and the surface of the water was measured on site at 34.0 feet. At about the beginning of the 2011 water year, on or about 29 September 2010, the United States Geologic Survey, Water Resources Division (USGS) established a new stream gauging station 14213090, identified as “Lake River at Ridgefield, WA”, at the location of the existing wooden bridge. At the time that the survey team obtained field measures of the existing bridge clearances the USGS river stage was 7.89(NGVD 1929), 8.29 feet (NGVD 1947), 11.57 feet(NAVD 88) or 7.31 feet (CRD), according to Reference 8.

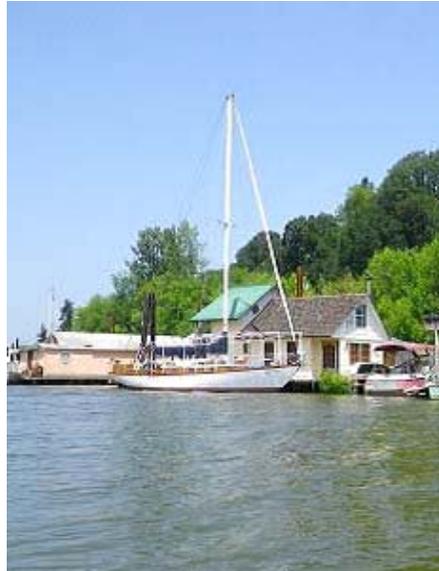
Figure 6 Largest Sailboat No. 3–55-foot Height

The boats operating on Lake River are recreational craft, small workboats, and houseboats. Many of the small craft operating on Lake River are launched from the Port of Ridgefield public boat ramp while many of the resident vessels are docked at the marinas. During the onsite survey, an average of 20 boats per day were seen using the boat ramp. The largest sailboats in the study area are listed in Table 3. In general, sailboat masts of this size are only removed with mechanical assistance (e.g., cranes). The tallest sailboat is pictured in Figure 6. The boat was recognized as a Cheoy Lee Offshore 40. The mast height is 55 feet.

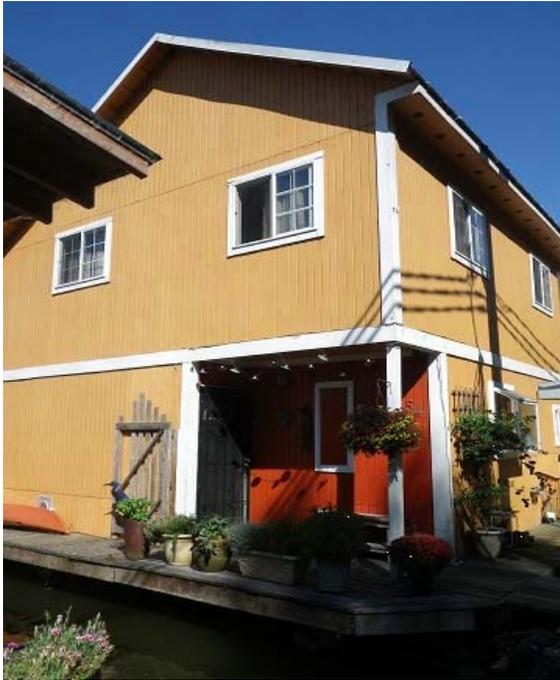
Figure 7. Tallest Houseboat at McCuddy's Marina, No. S23-34 ft

The field study found that the current highest houseboats between the two marinas is three stories high, located on McCuddy's Marina, with a height of 34 feet. Two McCuddy's residents currently own and actively use their sailboats. The sailboats' masts are 48-foot and 55-foot tall (measured from water line to top of the mast). McCuddy's Marina residents live downriver of the existing bridge; therefore, they do not currently have any existing clearance issues except for a Clark PUD (75'-V) power line paralleling Division Street in Ridgefield (see authorized permit in attachments).

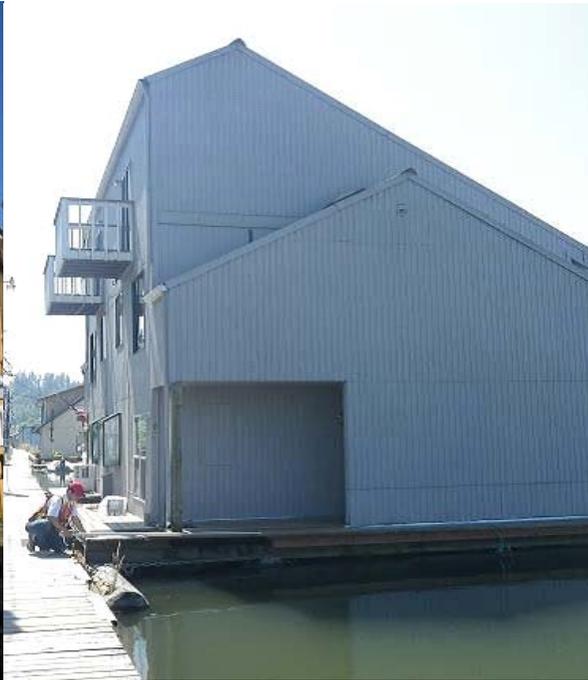
Figure 8. Tallest Houseboat at Felida Marina, No. 13 - 29 ft

Houseboats located at the second marina, Felida, are upriver of the existing bridge which currently limits vessel clearances. The current highest houseboat at Felida is 29-foot tall, and one sailboat with 34-foot mast (retractable).

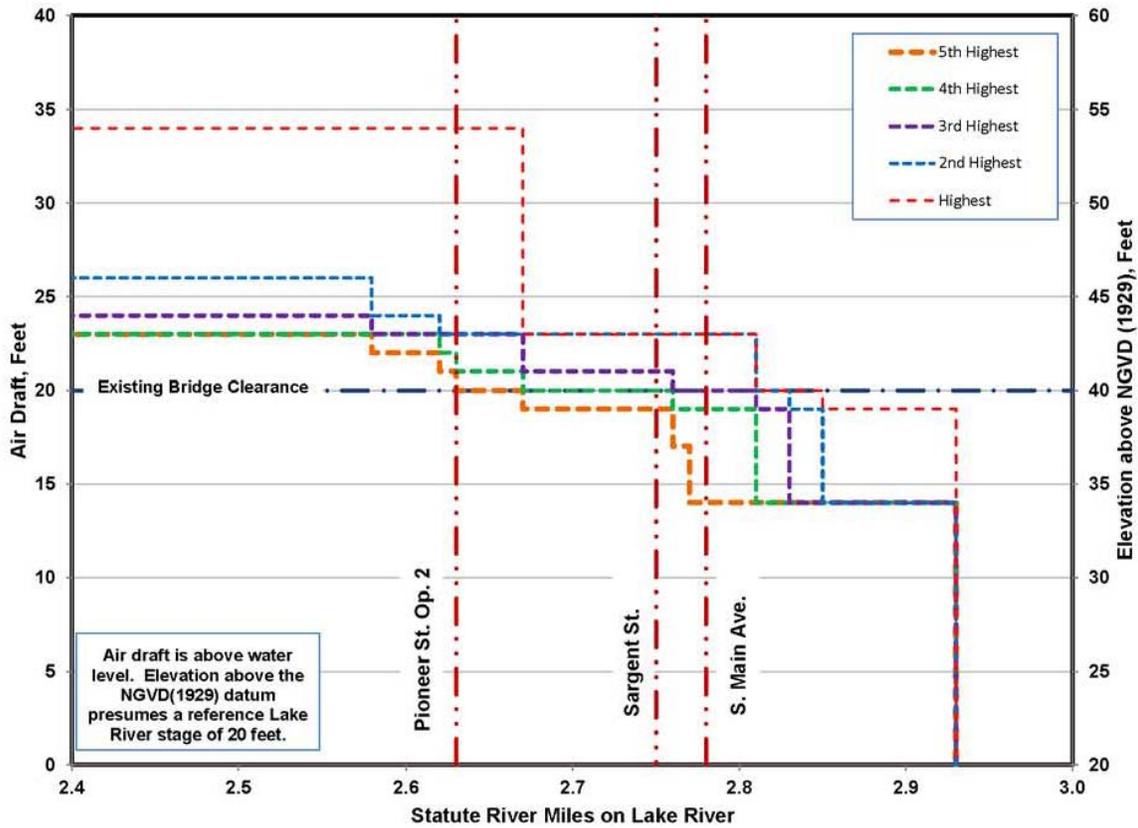
Along the river, from north (Columbia River) to south (Vancouver Lake), the air draft dimensions of the tallest houseboats are given in Figure 12 with respect to river mile between the north and south end of McCuddy's Marina (river miles 2.4 and 3.0 respectively) and referenced from the maximum annual elevation derived above. Three street locations from Reference 18 are noted with vertical red lines. At and above river mile 2.63 (Pioneer St. Op. 2), there are six houseboats taller than or equal to 20 feet and one houseboat taller than or equal to 27 feet. At and above river mile 2.75 (Sargent St.), there are three houseboats taller than or equal to 20 feet and no houseboats taller than or equal to 27 feet. At and above river mile 2.78 (S. Main Ave.), there are two houseboats taller than or equal to 20 feet and no houseboats taller than or equal to 27 feet. The height of the existing bridge is shown in blue dotted line presuming a USGS Lake River stage of 20 feet.

Figure 9. Air draft of 5 tallest houseboat upriver of river mile on Lake River
