Railroad Assessment

**Western Federal Lands
Highway Division
(WFLHD)**

Ridgefield River 'S' Unit

Date: September 7, 2012

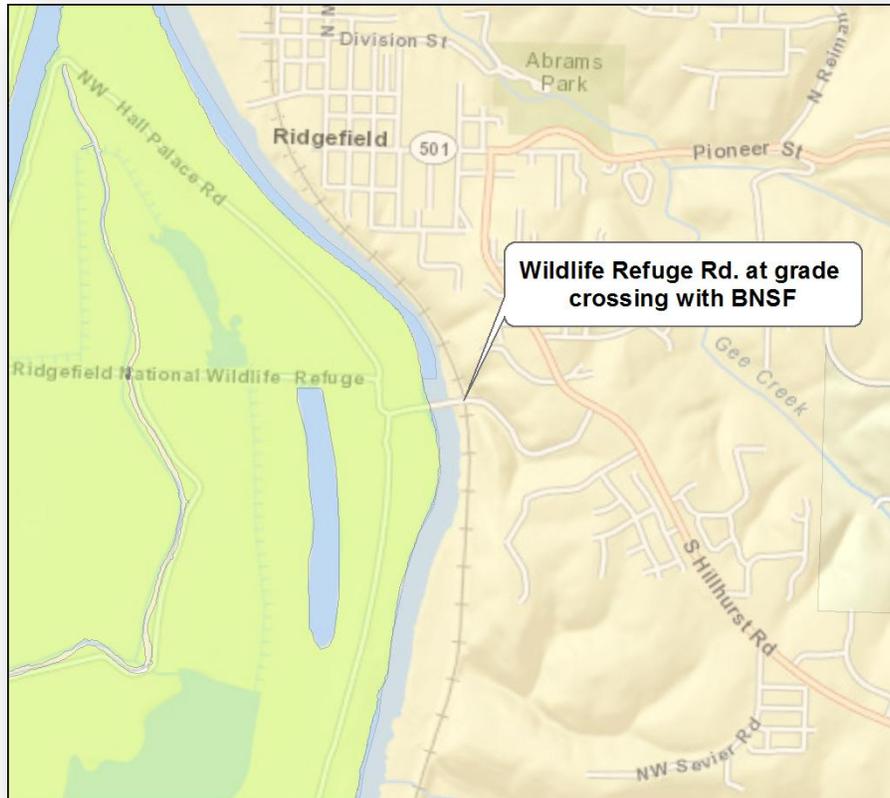
Figure 1. Location of Wildlife Refuge Road and BNSF Main Tracks

Wildlife Refuge Road crosses the BNSF Seattle-to-Portland main line near Ridgefield, Washington. This location is identified by BNSF as milepost (MP) 123.32 of its Seattle Subdivision, and the roadway/railway crossing is identified as USDOT Number 092425R.¹ Figure 1 shows the location of the crossing.

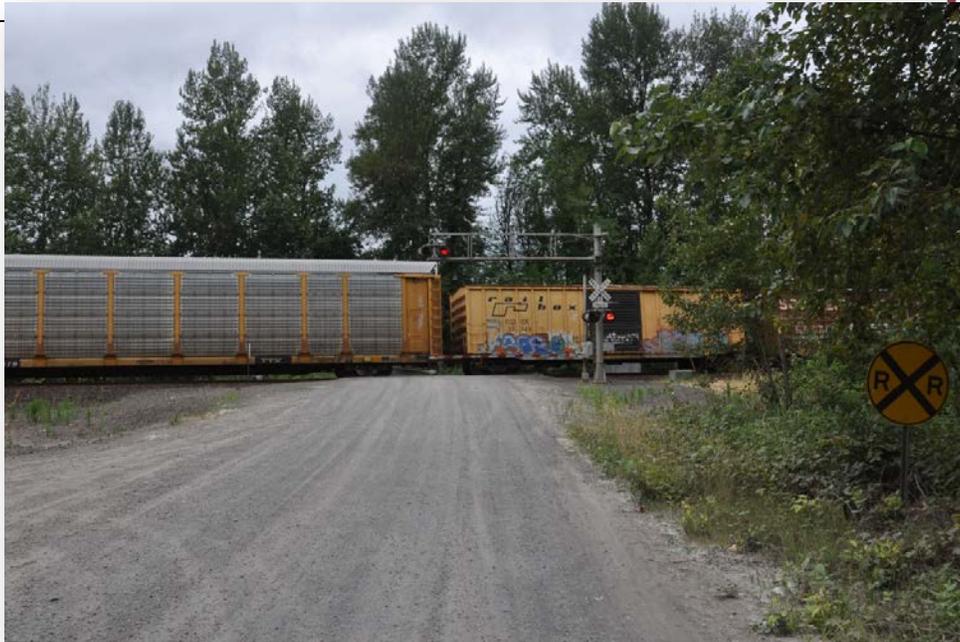
Figure 2. Wildlife Refuge Road, looking west toward the crossing, showing the warning signal system activated by a passing train.

The grade crossing surface of Wildlife Refuge Road and the BNSF Seattle Subdivision is a precast concrete panel crossing of each track maintained by BNSF. The crossing is equipped with active warning signal devices consisting of bells, flashing lights, and gates. Flashing lights are located in the direction of roadway travel, both to the side of the roadway on each side of the crossing, and above the roadway on a cantilevered mast. The crossing signals are activated by approaching trains.

While the USDOT inventory report is not clear, it appears the signal system is activated by a Constant Warning Time (CWT) Device, an electronic device that detects approaching trains, determines the speed of approaching trains, and activates the signal so that there is at least 25 seconds of warning time between the time the signal is fully activated and the arrival of an approaching train at the crossing. Grade crossing warning signal systems typically deactivate within 5 seconds after the train has cleared the crossing. Because the CWT is active on both main tracks, the crossing signal system may stay active after the exit of one train because a second train is approaching on the other track. The crossing signal system is maintained by BNSF.

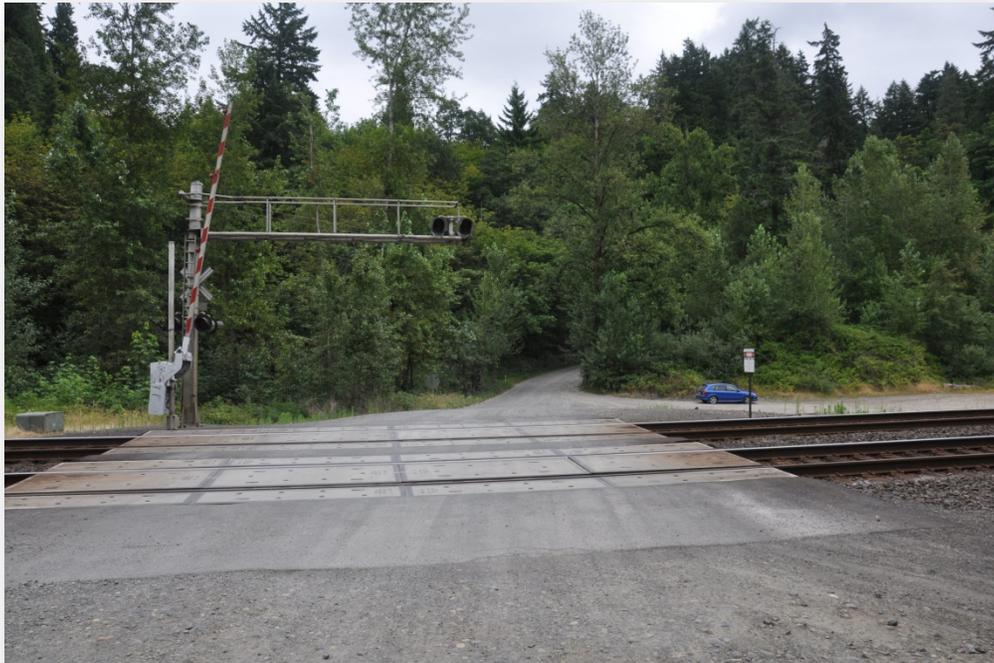
Figure 3. Wildlife Refuge Road, looking east through the crossing, showing concrete panel crossing surfaces and asphalt paving approaches to the crossing.

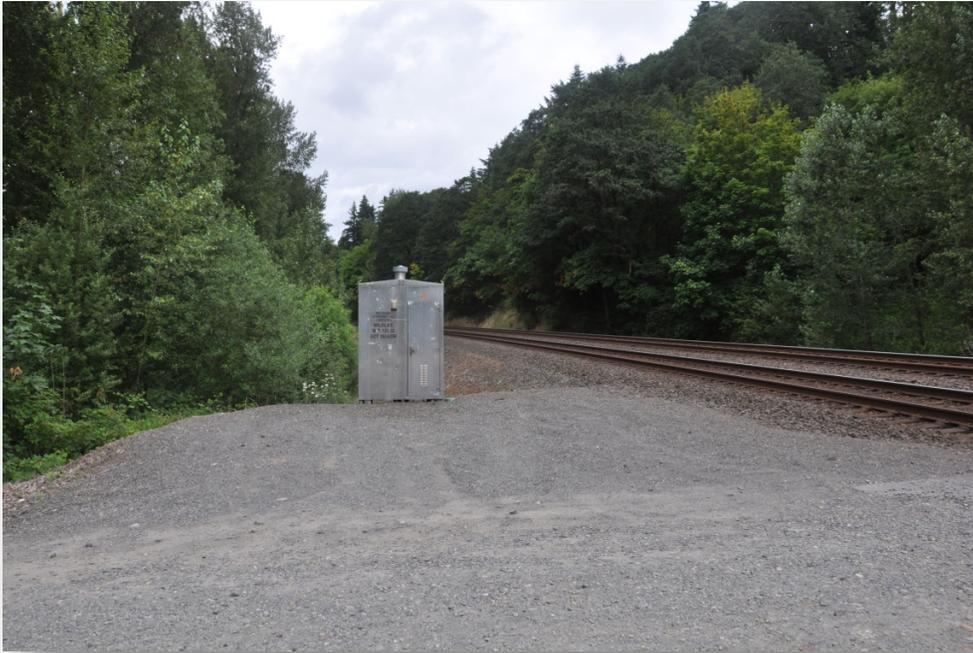
Figure 4. Wildlife Refuge Road crossing, looking north. The silver structure is the instrument house that contains the electronic equipment that controls the warning signal system.

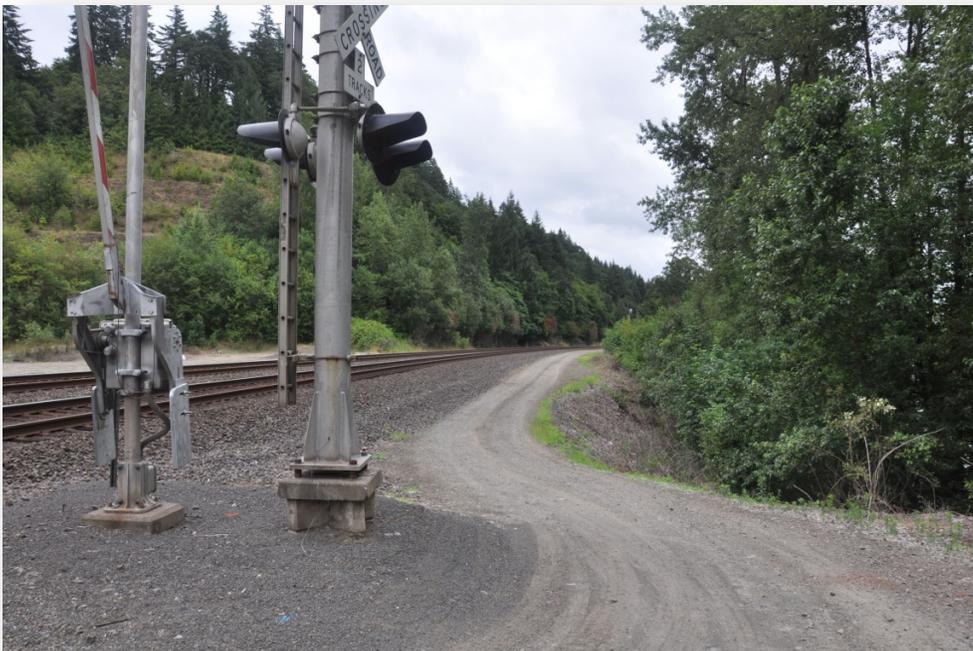
Figure 5. Wildlife Refuge Road crossing, looking south from the west side of the BNSF main tracks. This figure and Figure 4 illustrate the curvature of the BNSF main tracks at this location.

BNSF’s main line at this location consists of two main tracks². Both tracks are of typical construction for North American Class 1 railways. The crossing occurs within a 2 degree, 0 minute curve of the main tracks; the curve is approximately 2,500 feet long and the crossing is located approximately 800 feet from the southern end of the curve. The main tracks at this location have a maximum authorized speed of 79 mph for passenger trains using Talgo³ equipment, 70 mph for passenger trains using conventional equipment, and 50 mph for freight trains. The main tracks at this location are operated as Centralized Traffic Control (CTC), a method of operation in which trains proceed according to the visual indications provided by signals located along the tracks, or by verbal instructions

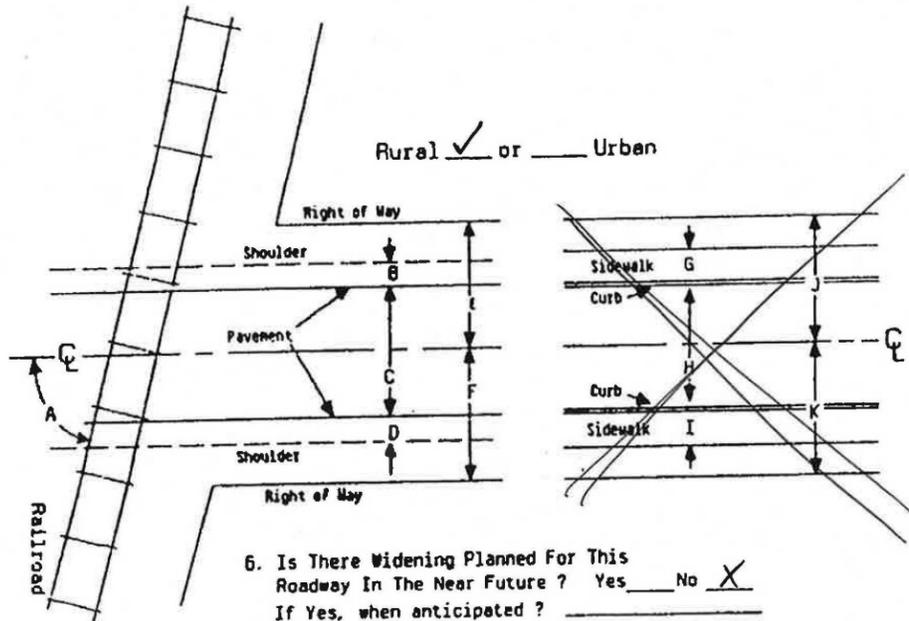
1. Agency Name FHWA WFL
2. Location of Crossing BNSF & Wildlife Refuge Rd RR MP 123.32
3. Number of Traffic Lanes 2 Railroad Tracks 2
4. Crossing Number Available from Railroad DOT # 092425 R
5. Statistics:

A <u>81°</u>	D <u>0</u>	H <u>-</u>
B <u>0</u>	E <u>-</u>	I <u>-</u>
C <u>23'</u>	F <u>-</u>	J <u>-</u>
	G <u>-</u>	K <u>-</u>

Figure 9. Geometry of the Wildlife Refuge Road crossing as of July 2012.

Figure 2 through Figure 8 illustrate the Wildlife Refuge Road crossing as of July 2012. Figure 9 shows the geometry of the road crossing.
