Otis Tufton Mason House:

Otis Tufton Mason House: Context and Assessment

Fairfax County, Virginia

April 25, 2014 • Draft Report
New South Associates Technical Report 2378

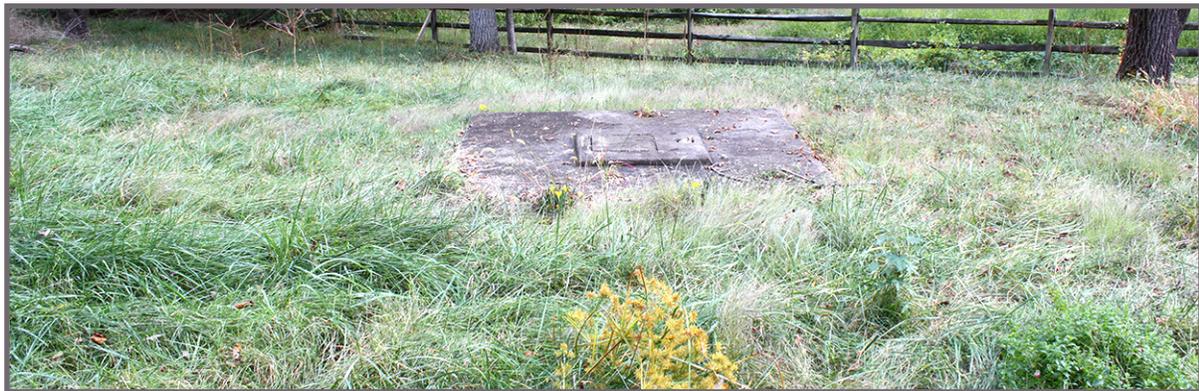
Figure 55. Looking Southeast to Covered Well

A well with a square-shaped cover is located southeast of the house (Figure 55). During 1970s restoration work, a trench was dug to link a new sump pump from the cellar to this well. Another manmade maintenance element is located east of the circa 1880 addition. Covered by a concrete slab and plywood topped with pylons, maintenance files state that this rectangular-shaped area marks that a septic tank was installed at this location in 1968 (Figure 56).

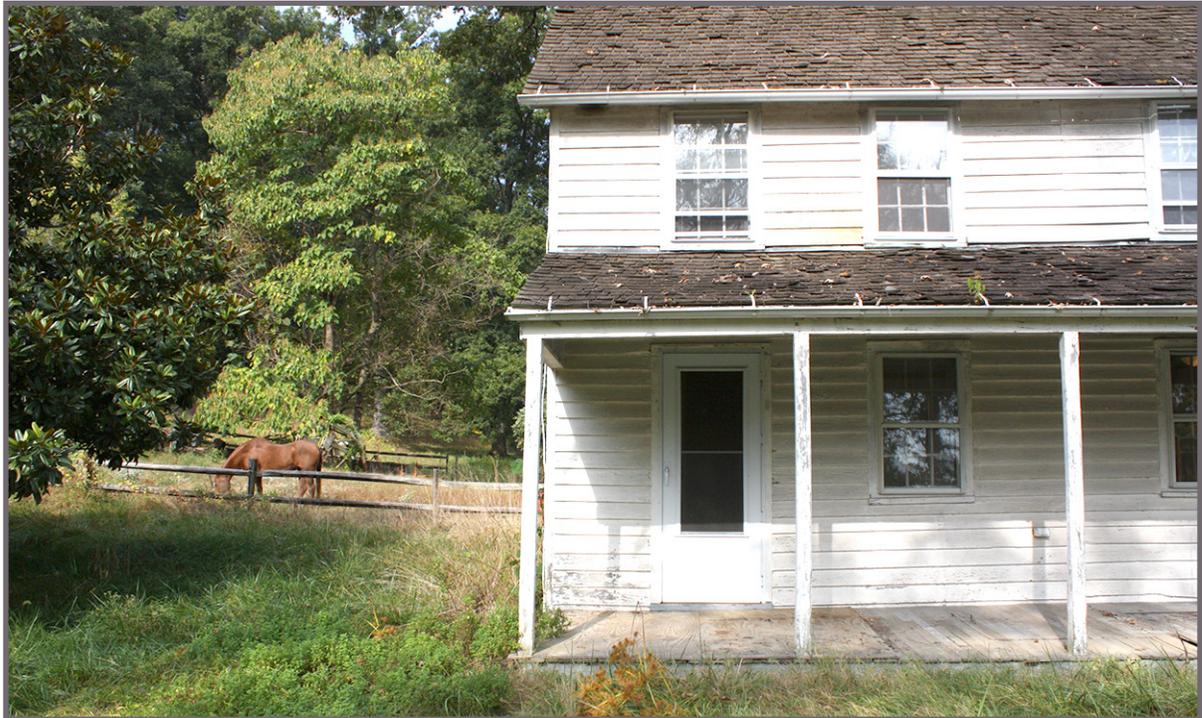
Figure 57. Looking Northwest to Grazing Area and Otis Tufton Mason House

The area just northwest of the fence, which is now primarily used for horse grazing, was once directly associated with the house (Figure 57). Here, what was once the primary, narrow driveway for the house remains flanked by five mature oak trees before looping back south toward the stream bridge (Figures 58 and 59). The driveway trace remains visually detectable from on-site views, though the tree canopy shields visibility from most aerial views (Figure 60).

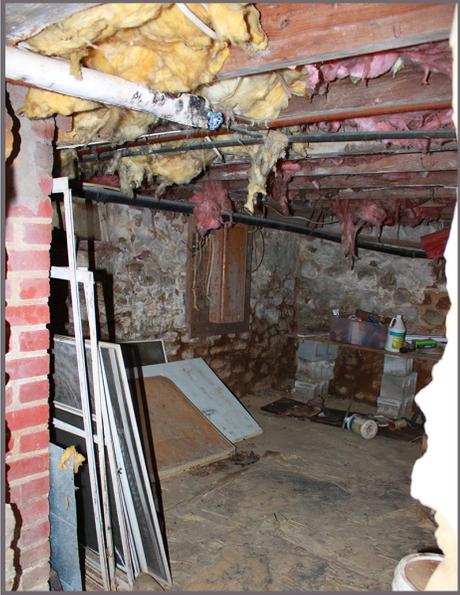
Description	
CELLAR	<p>The roughly 14'-3" x 11'-8" cellar has a post-1930s poured concrete floor and fieldstone foundation walls. While fieldstone walls may have initially been dry laid, mortar and plaster patching both between and atop stones is evident.</p>

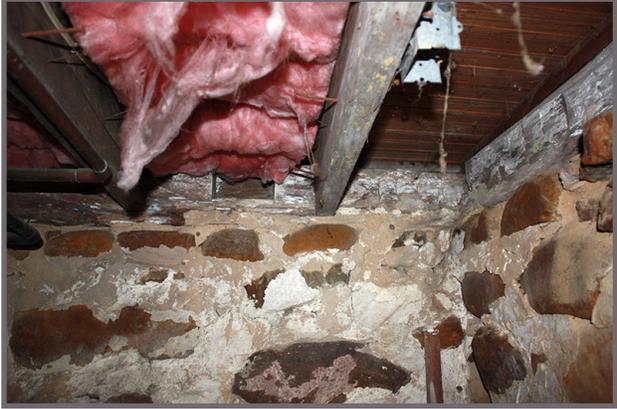
Description
CELLAR	<p>Original and replacement structural members supporting the central portion of the building are visible from the cellar interior. From the cellar, notches in hand-hewn sills show the location of original hand-hewn sills alongside later-installed replacement joists.</p>

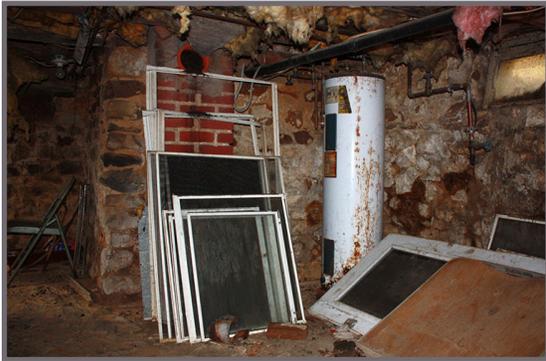
Looking West

Non-historic, replacement bricks compose the section of the chimney visible from the cellar interior.

Modern updates and appliances located in the cellar include a water heater, electrical panel, a light fixture and switch, and rolled fiberglass insulation.

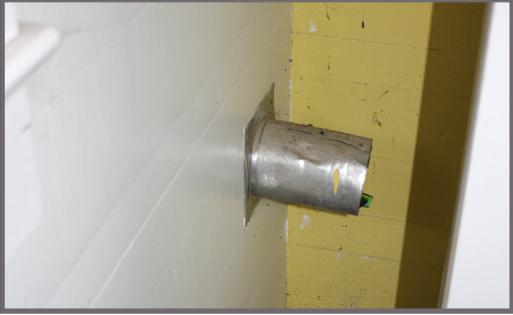
<p>Southeast Wall</p>
	<p>A metal vent marks the former location of an appliance in the room's north corner.</p>

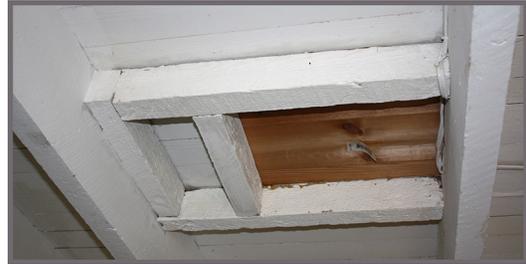
Ceiling Patch

Exposed joists compose the ceiling, which has a full height of 7'-10" and 7'2" to joist base. Joists are spaced 1'-9½" apart from one another. Above the stove, a joist-framed patch in the ceiling is covered in plywood. A non-historic, centrally set ceiling fan is located in the ceiling.

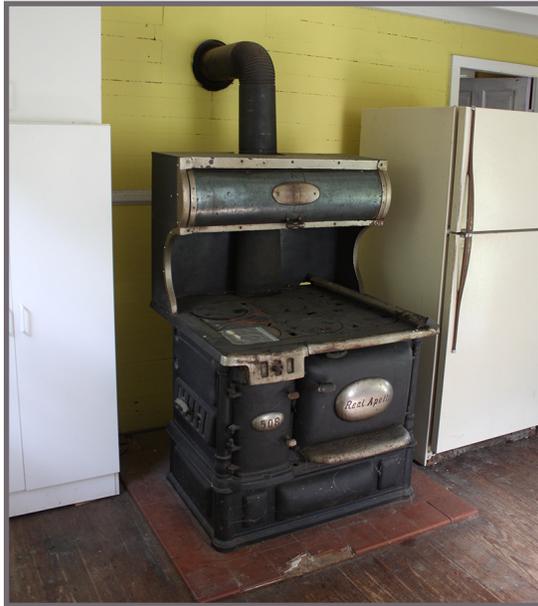
Looking Northeast

A large Real Apollo stove from W.S. Jenks & Son of Washington, D.C. is centrally set along the northeast wall. The stove sits atop a pad of quarry tiles and plywood. Some damage is evident in the tiles.

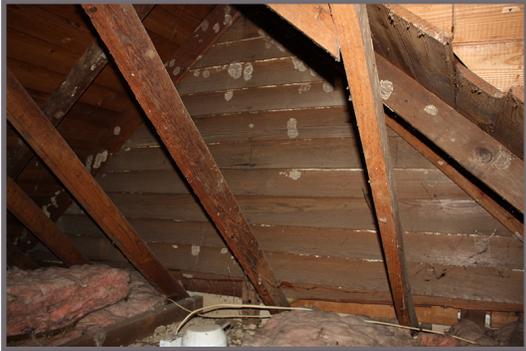
<p>Original Northeast Gable End</p>
	<p>Rafters are tied to joists via salvaged painted and unpainted tongue-and-groove boards. Some boards have minor damage, but evidence of insect damage was not apparent during the site visit. Tongue-and-groove boards top the rafters, and untrimmed ends of such boards are visible at the juncture of the two gables.</p>

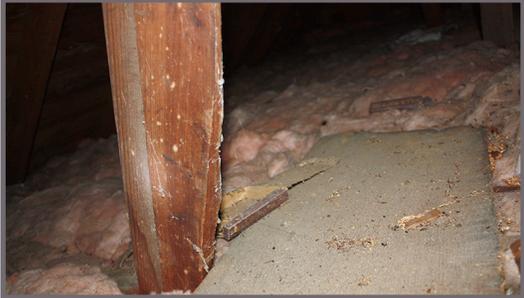
<p>Damaged Board</p>

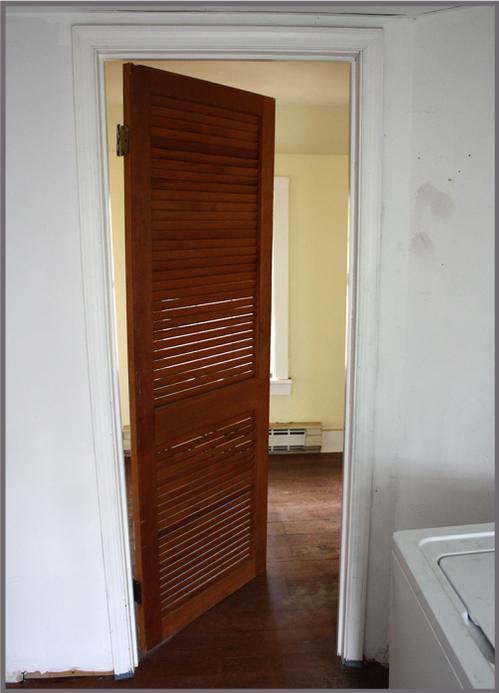
<p>Baseboard Remnant</p>	<p>Looking Southeast</p>	
	<p>A two-panel, wood louvered door with a metal handle and a missing hinge hangs gingerly from the door frame.</p>

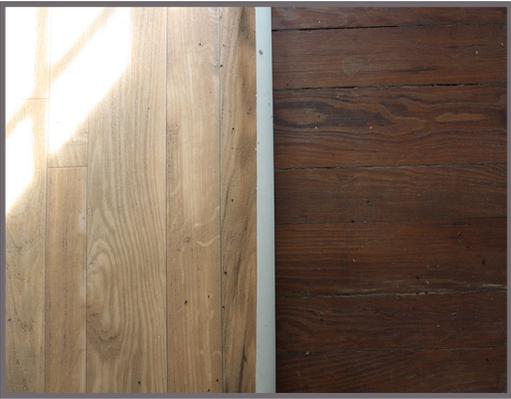
Description
CIRCA 1873 ADDITION - BEDROOM	<p>The wood plank flooring is almost completely covered by a rolled vinyl floor covering. Along the floor perimeter, the vinyl covering is tucked below the baseboard.</p>

<p>Vinyl (Left) and Wood Plank (Right)</p>

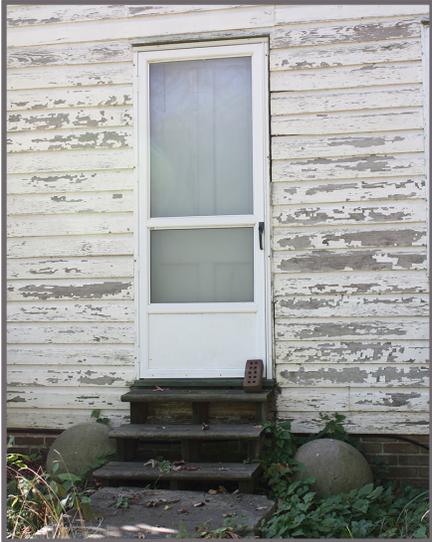
Description	
EXTERIOR	<p>The main entrance door was not operable during the site visits of the current study.</p>

<p>Main Entrance</p>
	<p>The kitchen door on the northwest elevation was also inoperable during site visits.</p>

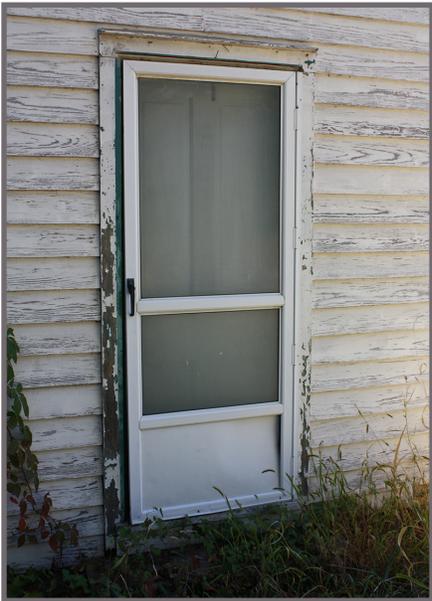
<p>Kitchen Door</p>

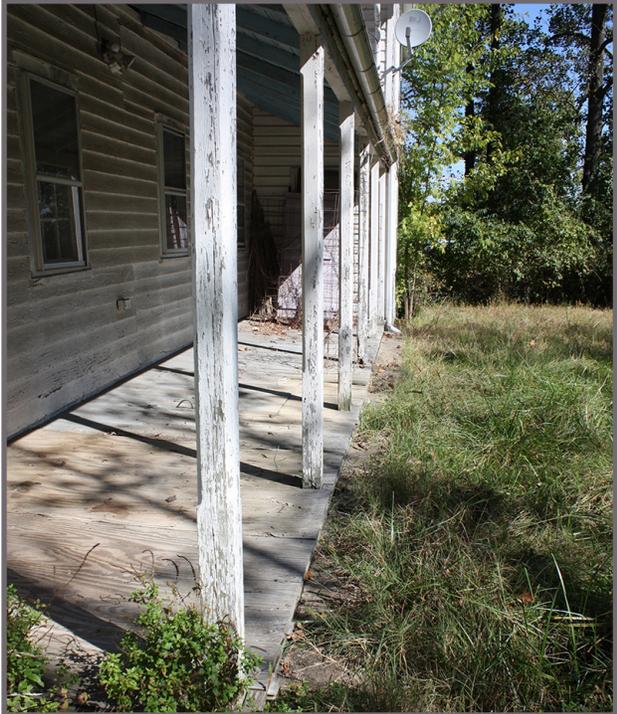
<p>Shifting Floorboards</p>
PORCH	<p>Paint is peeling from chamfered porch posts.</p>

<p>Pealling Paint</p>

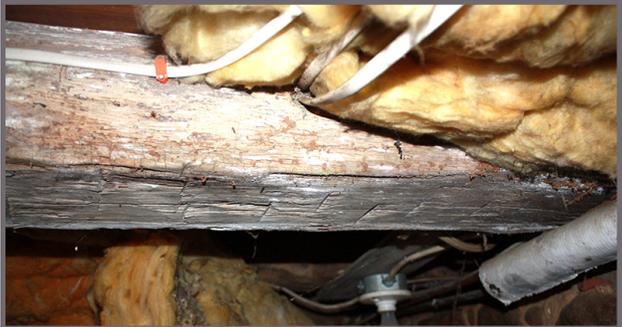
Description
CELLAR	<p>Some insect damage was visible in the sill marking the southwest wall of the original building.</p>

<p>Southwest Sill</p>
	<p>Rolled fiberglass insulation is damaged and falling.</p>

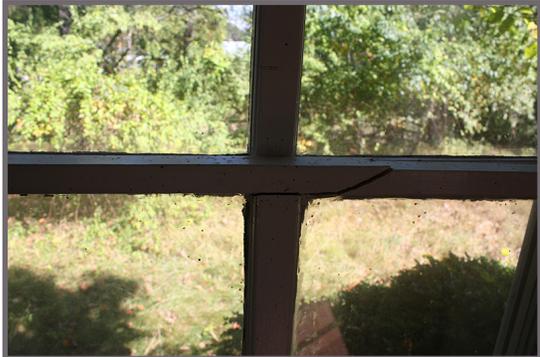
Description
PARLOR	<p>The window to the right of the door in the northeast wall has a broken muntin, while the window to the right of the stove in the northwest wall has a broken pane.</p>

<p>Broken Muntin, Northeast Wall Window</p>

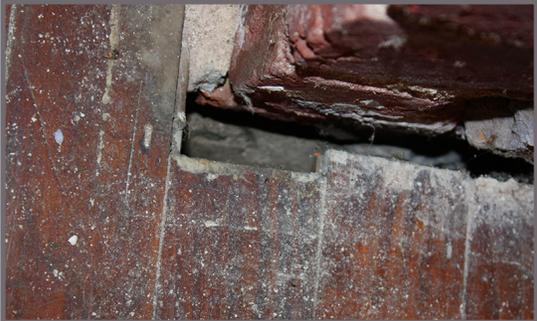
Description
DINING ROOM	<p>Damage in the dining room includes minor gaps and cracks in floorboards.</p>

<p>Floorboard Gap</p>
	<p>Damage in the floorboards is evident along the northwest wall near the stairwell.</p>

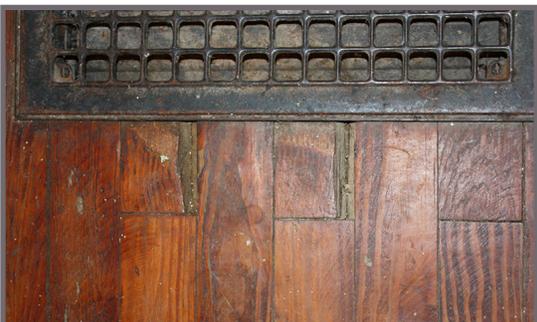
<p>Gap at Chimney with Sprayed Insulation</p>
	<p>Minor cracks in floorboards surround the metal floor vent.</p>

<p>Cracks Near Vent</p>

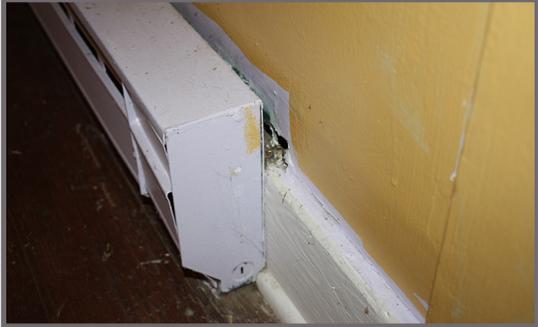
Description	
DINING ROOM	<p>Drywall damage is visible behind the northern-most heater on the southeast wall.</p>

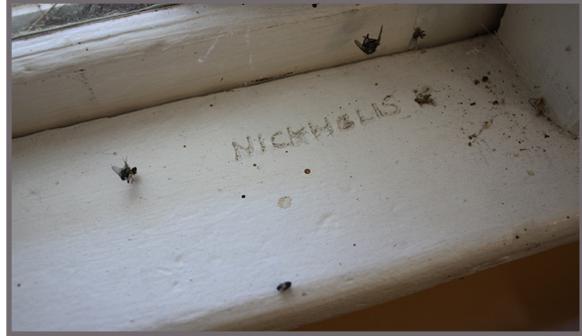
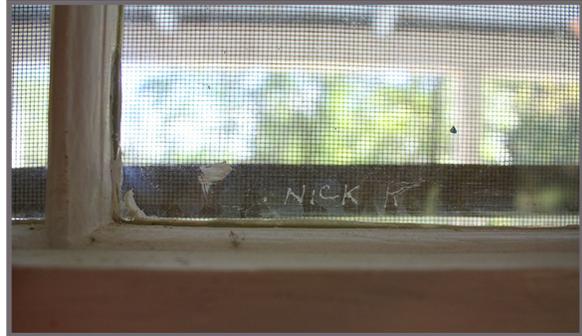
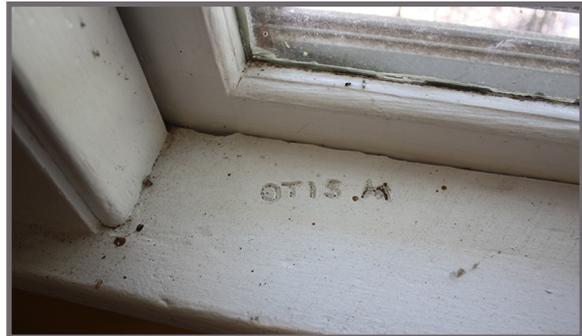
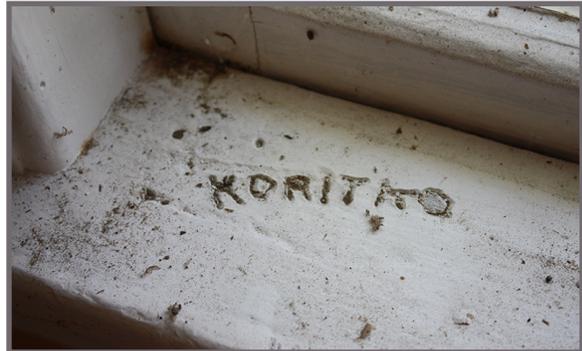
Names carved into the sills of the northwest wall window and the window to the left of the door in the southeast wall, and into a pane in the same southeast wall window suggest that such graffiti was added as late as 2006. At least one sill bears the name of the building's last tenant.

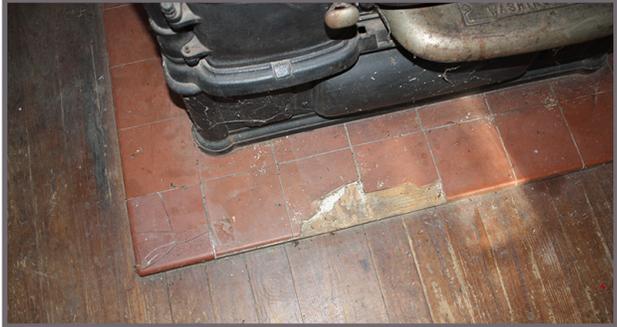
Description
	<p data-bbox="240 478 587 585">A damaged quarry tile-and-plywood pad carries the Real Apollo stove in the kitchen.</p>

<p data-bbox="729 684 867 711">Damaged Tile</p>

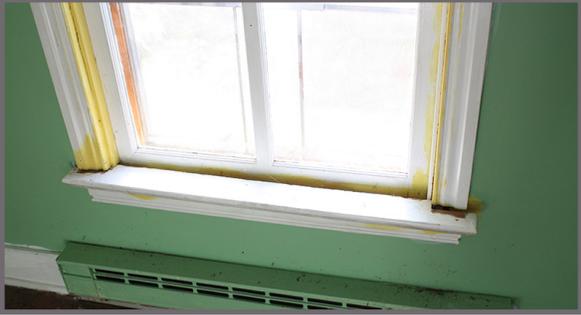
<p>Damaged Wood Strips</p>
<p>The windowsill on the southeast wall of the larger room is currently detached.</p>

<p>Detached Sill</p>	
<p>Above the southeast wall window is a small insect nest.</p>

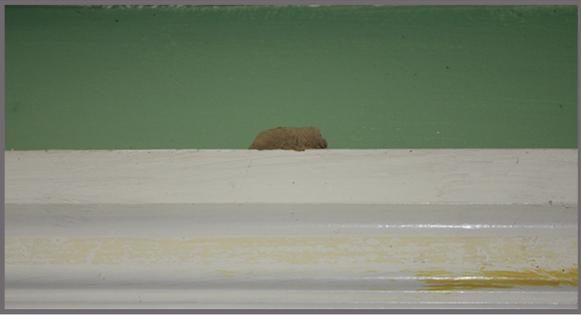
<p>Insect Nest</p>

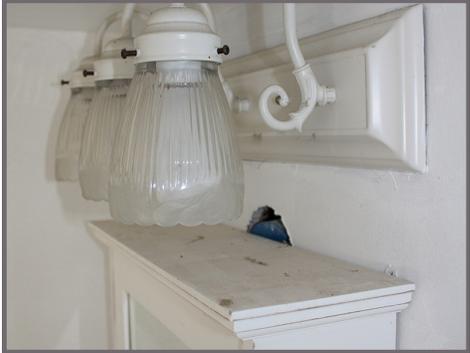
Description
BATHROOM	<p>A large drywall hole is visible from just above the vanity.</p>

<p>Drywall Hole</p>
	<p>The louvered door is missing its upper hinge.</p>

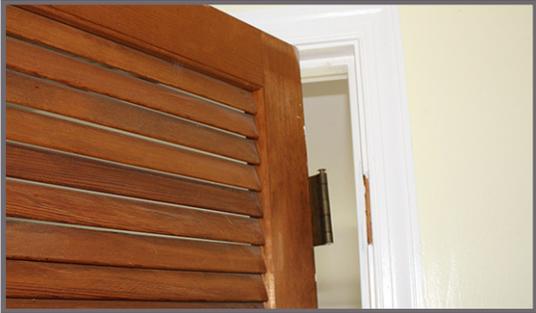
<p>Detached Hinge</p>
LAUNDRY ROOM	<p>Insect damage is evident in the muntins of the southeast window.</p>

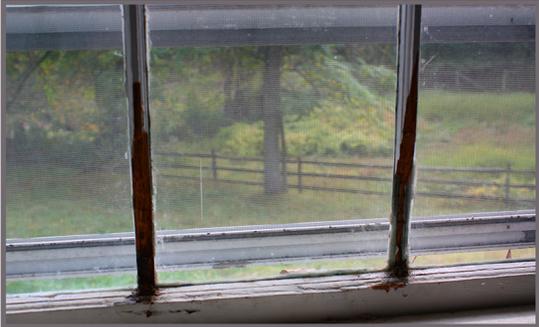
<p>Muntin Damage</p>
	<p>Some baseboards have been removed from this room. Small drywall holes are also evident in this area.</p>

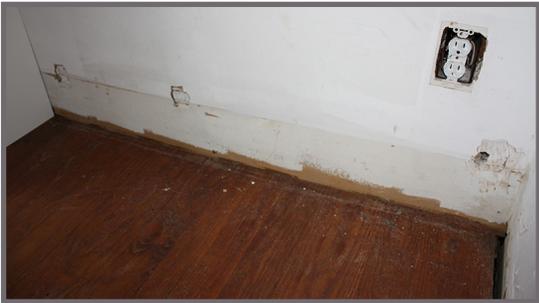
<p>Missing Baseboard</p>

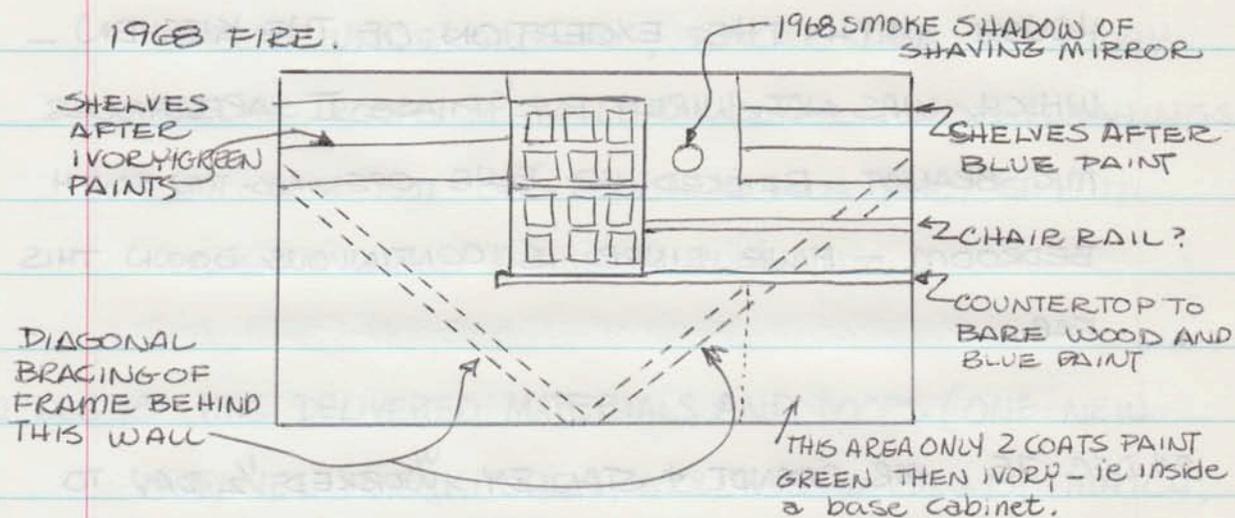
SOUTH KITCHEN WALL - LAYERINGS OF PAINT INDICATE WHAT WAS ADDED, FROM ORIGINAL TO 1968 FIRE.

WEST WALL IS ALL NEW CONSTRUCTION, DATING FROM AFTER THE 1968 FIRE. EAST & NORTH WALLS SHOW A CHAIR RAIL ABOUT 4' FROM FLOOR - THIS IS A BIT HIGH FOR REGULAR CHAIR RAIL.

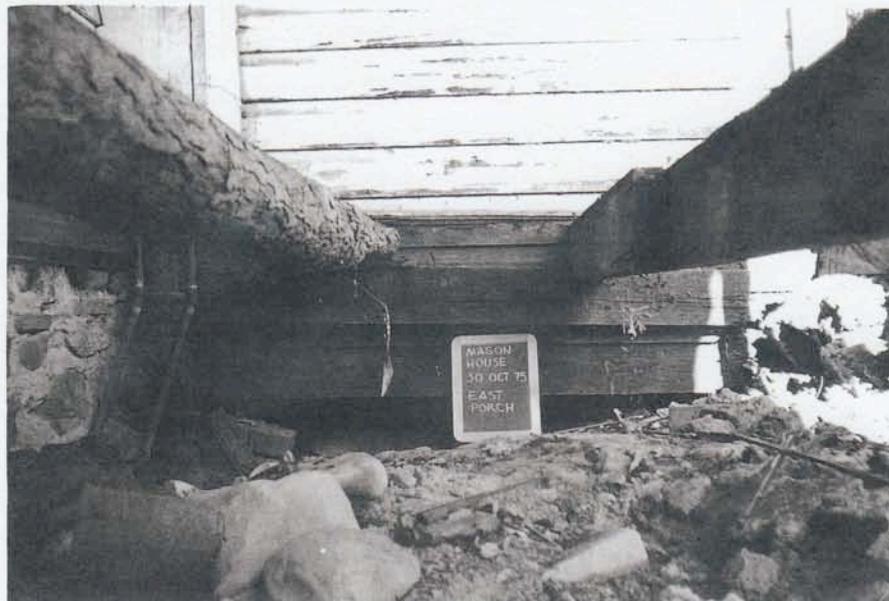
Photo No.: 7-5

1 ORIGINAL LOG JOIST; ALSO
PLUMBING TO BE REPLACED

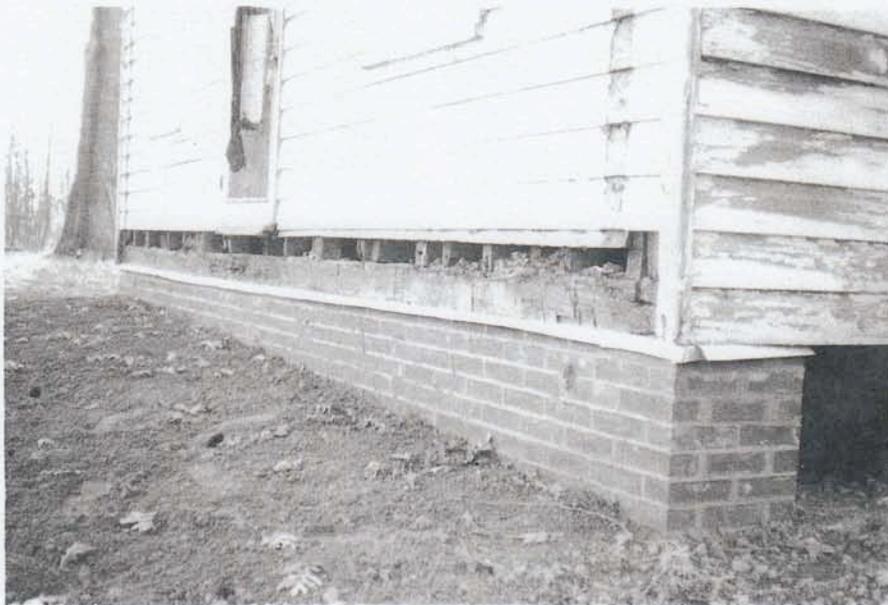
View: NEW 1975 NORTH
FOUNDATION

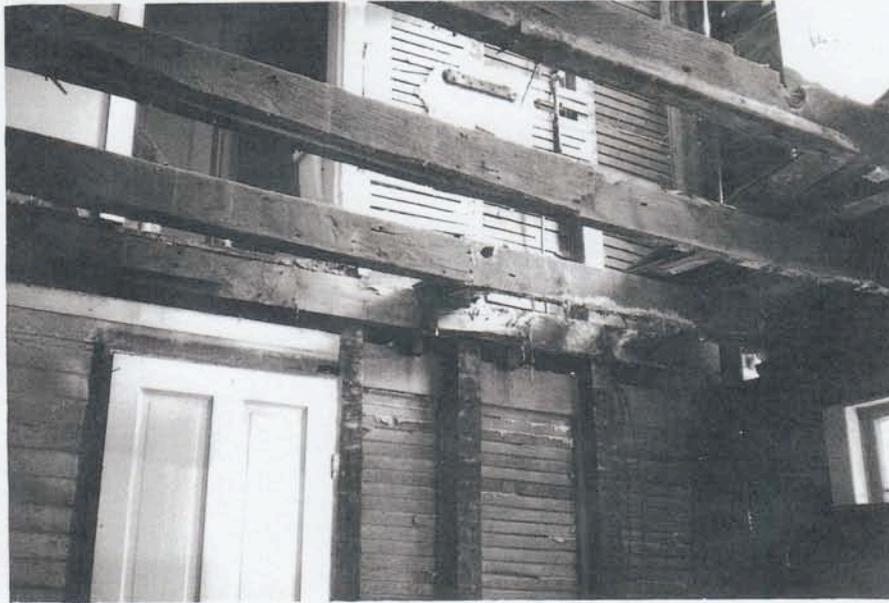
Photo No.: 9-3

Remarks: NOTE MANY PATCHES AND CRACKS

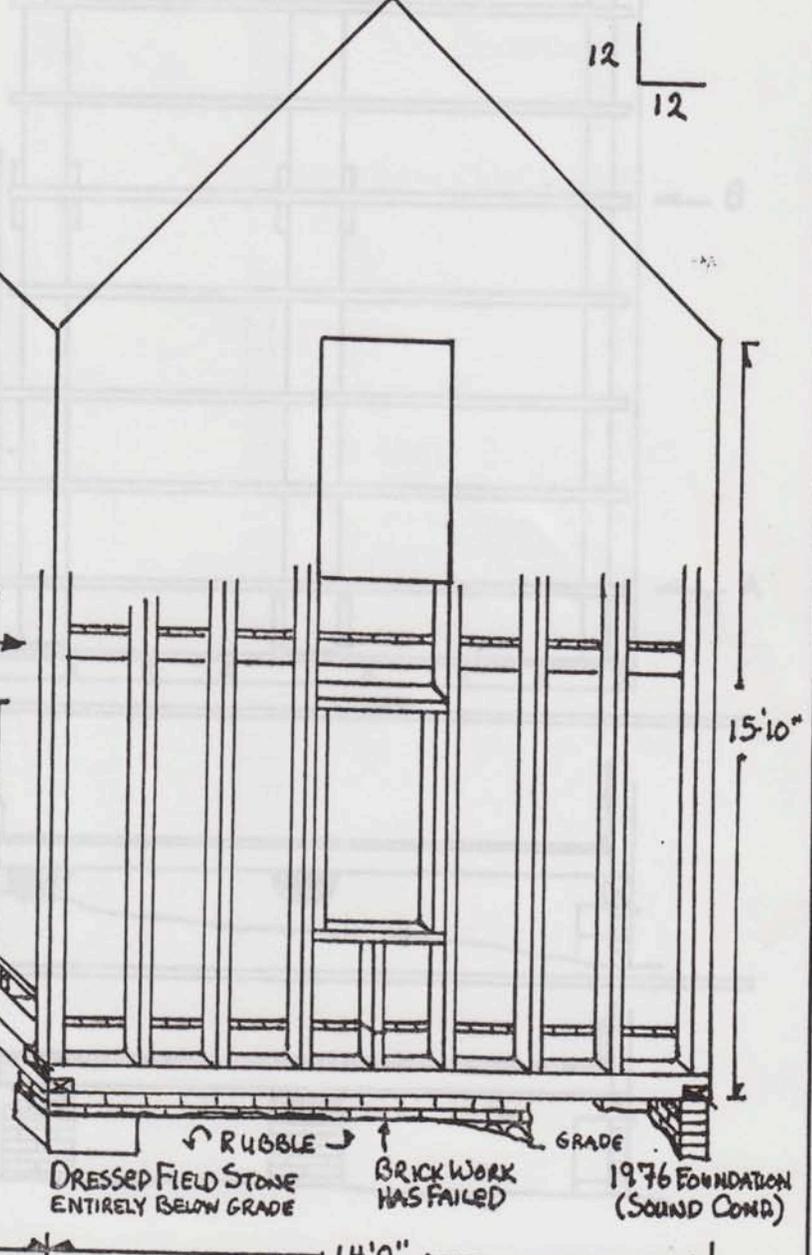
FIRST STUD, SE WALL, RUINED

→ THESE MEMBERS ARE PROVIDING
NO SUPPORT FOR STRUCTURE!

↑
BRICK WORK
HAS FAILED

1976 FOUNDATION
(SOUND COND)

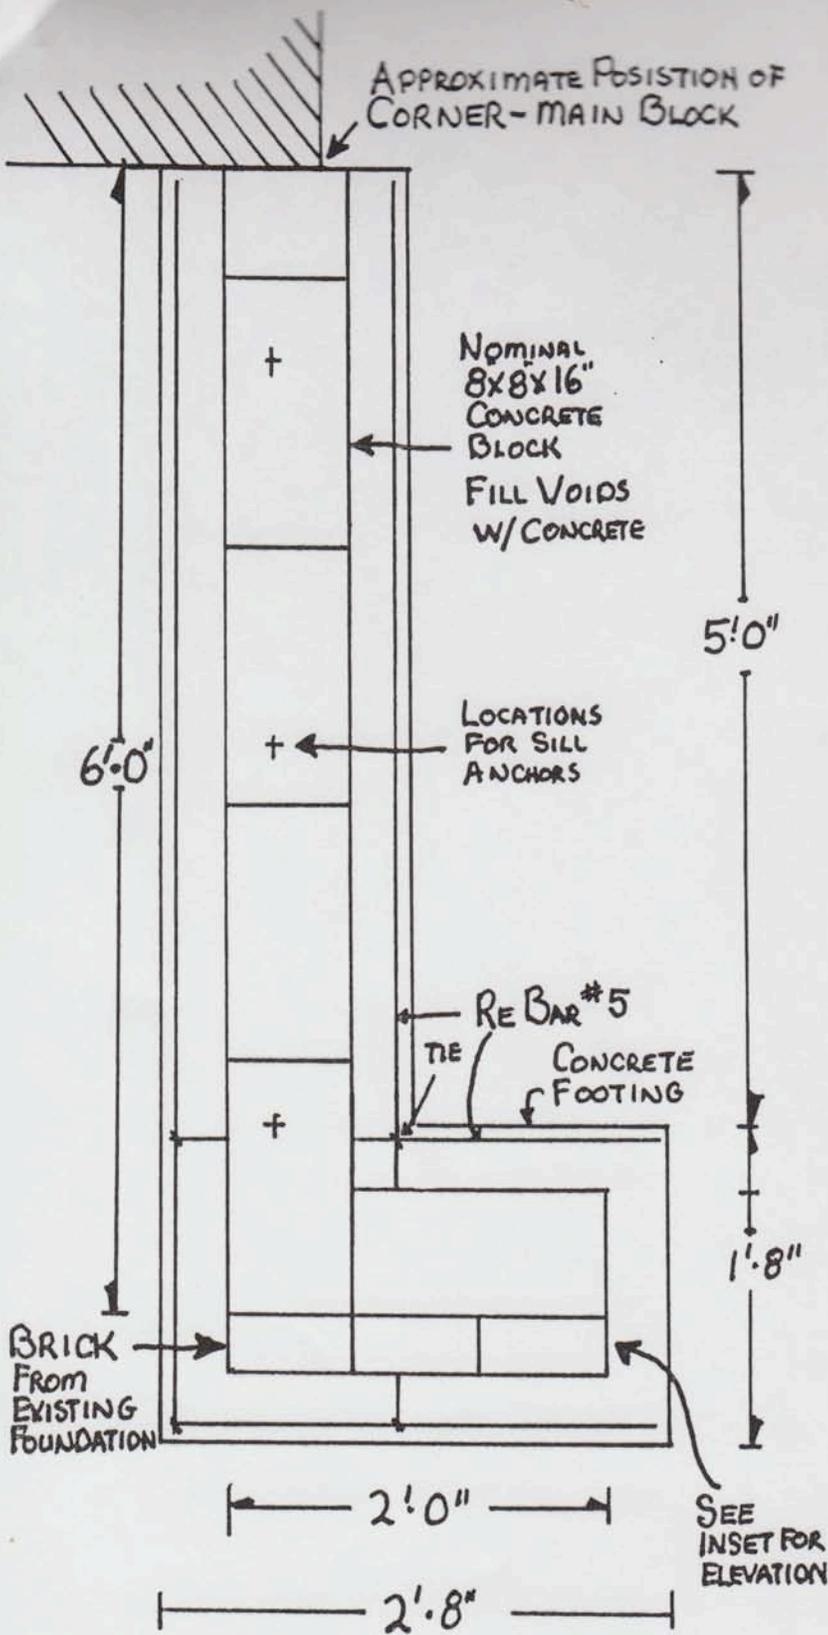
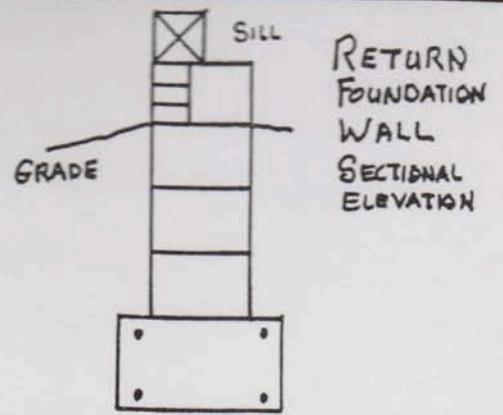
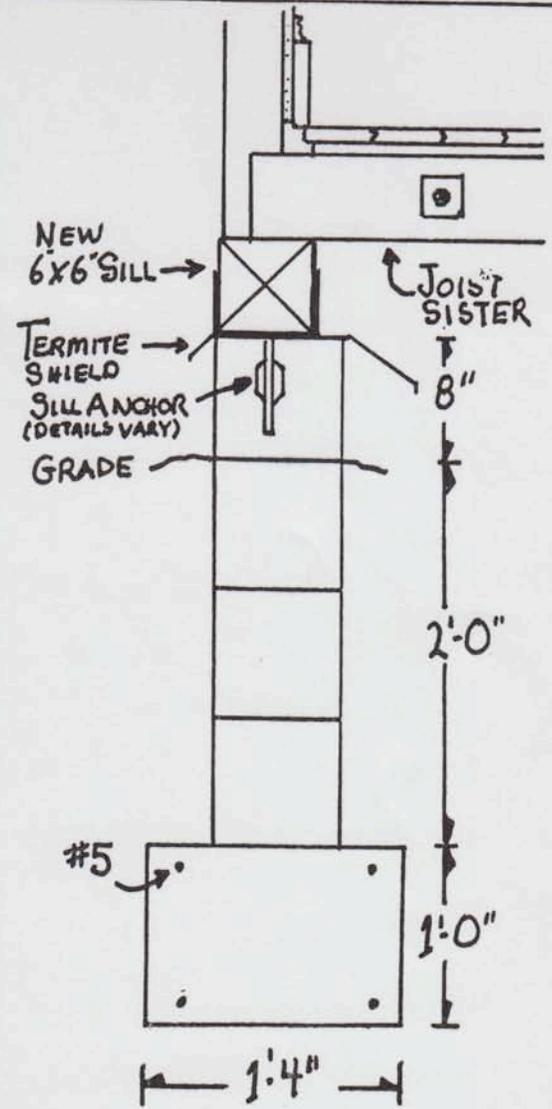
WOODLAWN PLANTATION: MASON HOUSE 9/14/92
 FOOTING & FOUNDATION PLAN & ELEVATIONS
 1893 ADDITION: S CORNER RESTORATION
 DRAWING SCALE: 1" = 1'-0" / INSET 1/2" = 1'-0"
 FOOTING DESIGN: GORDON ECHOLS, ARCHITECT 7/16/92

NW-SE FOUNDATION WALL SECTIONAL ELEVATION
